# **GEOTECHNICAL EVALUATIONS/FIELD SUVEYING SERVICES/ DISTRESS SINKHOLE & CRACKING EVALUATIONS**

Frog Hollow Dam (UT00418)  
Washington County, Utah

RA Project No. 8384-14-008  
June 27, 2016

**Subject: Geotechnical Evaluations / Field Surveying Services /  
Distress Sinkhole & Cracking Evaluations**  
Frog Hollow Dam (UT00418), Washington County, Utah  
RA Project No. 8384-14-008

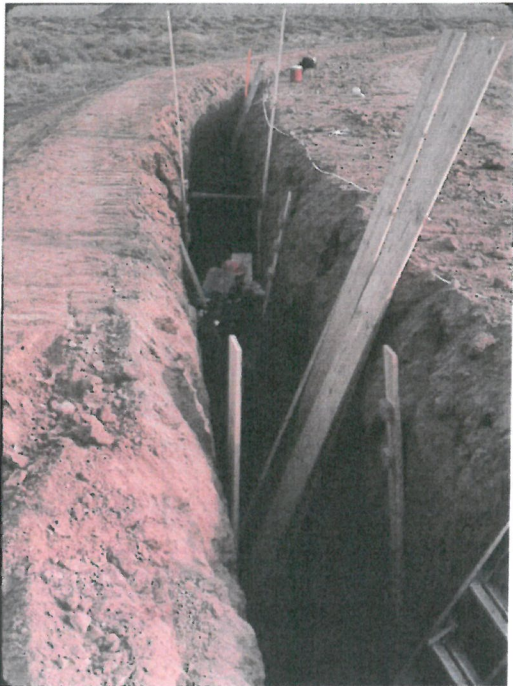
**Photograph 1:** Chimney drain excavation.

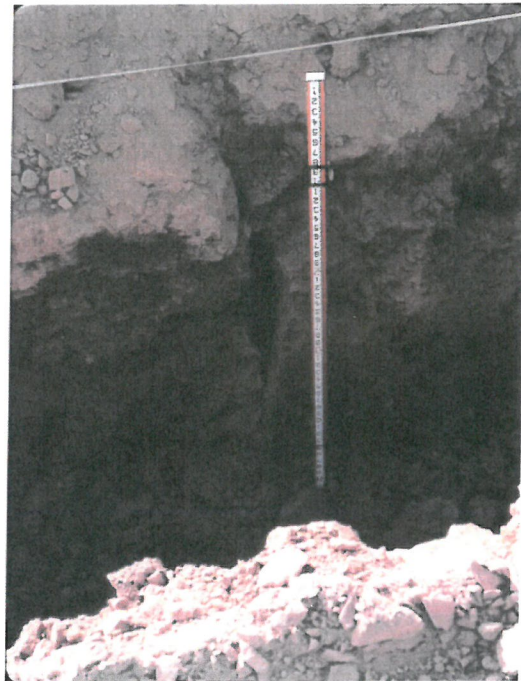
**Photograph 2:** Exposed transverse crack.

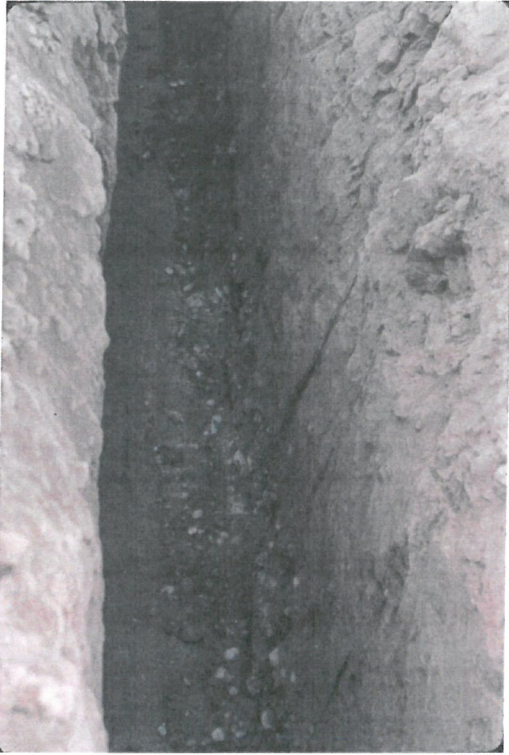
**Photograph 3:** Exposed transverse cracks.

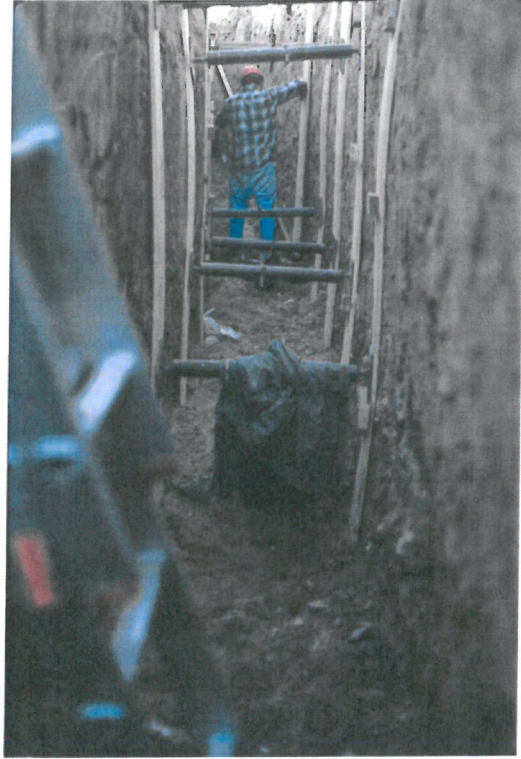
**Photograph 4:** Chimney drain excavation.

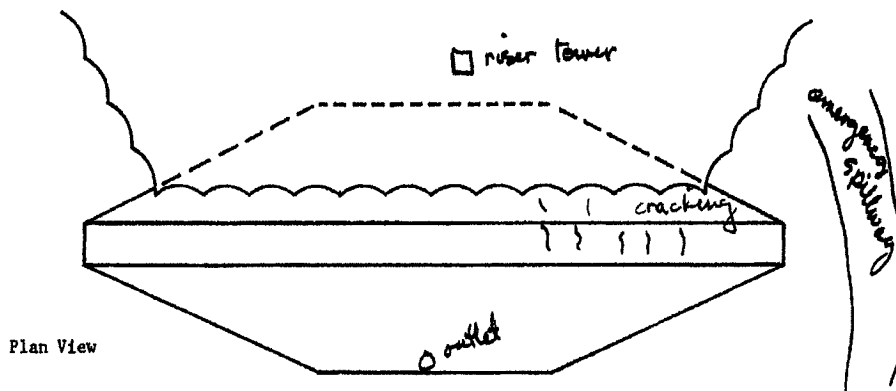
**Figure 2.9a: Surface Cracking on the Upstream Face of the Embankment, (DWR, 1982a)**

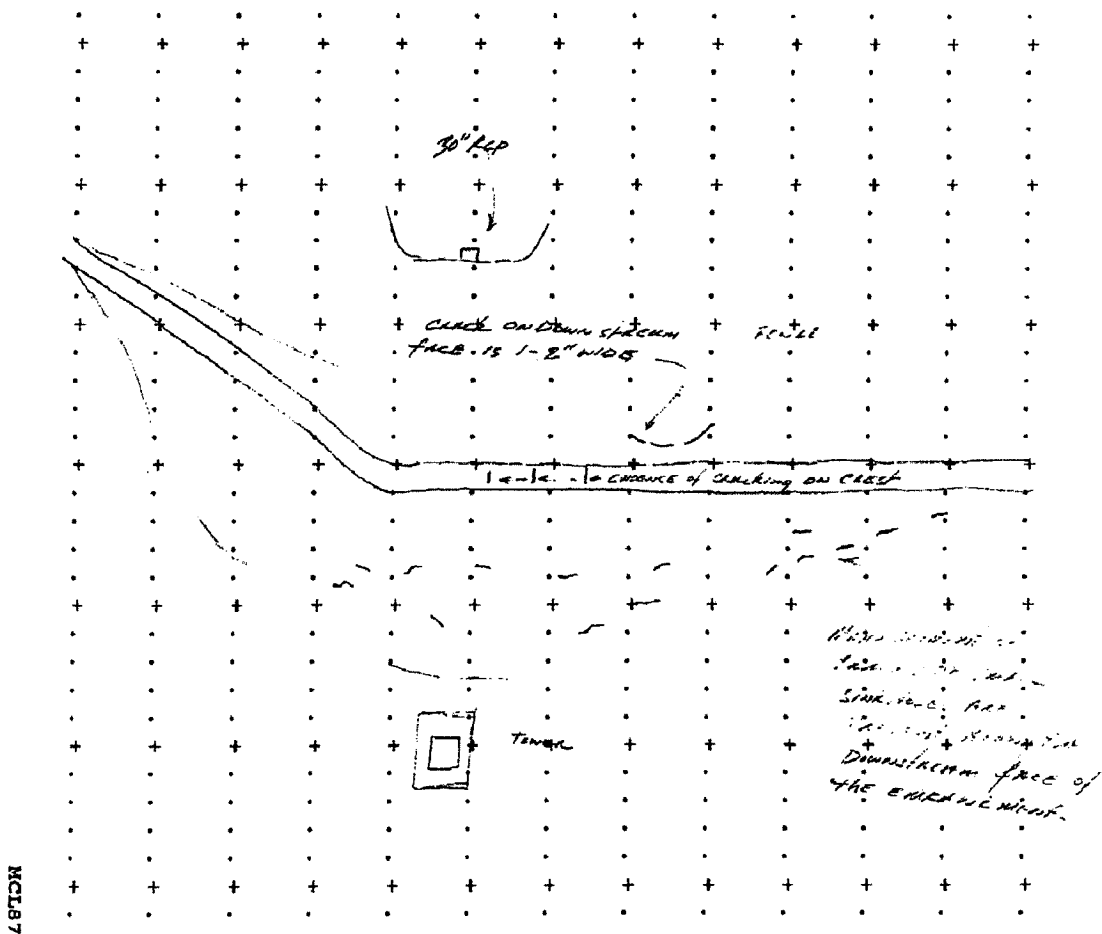
**Figure 2.9.b: Sink Holes on the Upstream Face of the Embankment, (DWR, 1982c)**

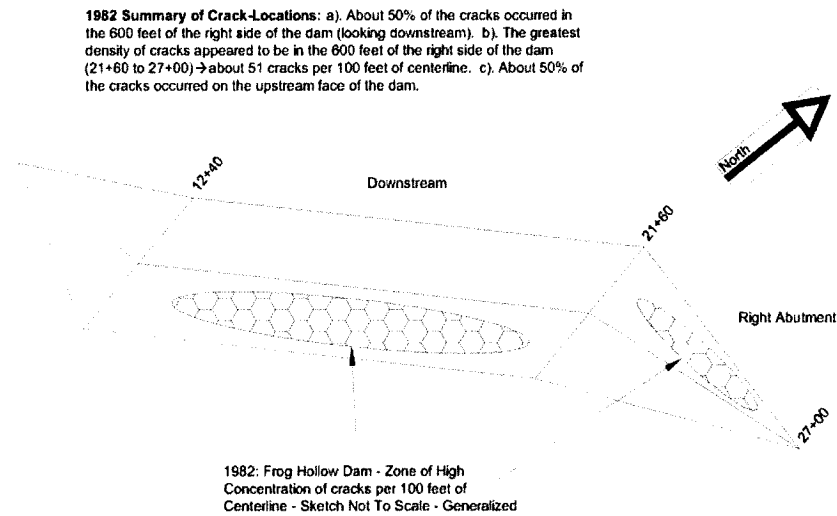
**Figure 3.10: Frog Hollow Dam Cracking Locations, (NRCS, 2006)**

Sketch of Frog Hollow Dam cracking locations - adapted from Rasely, NRCS 1982 Field Notes

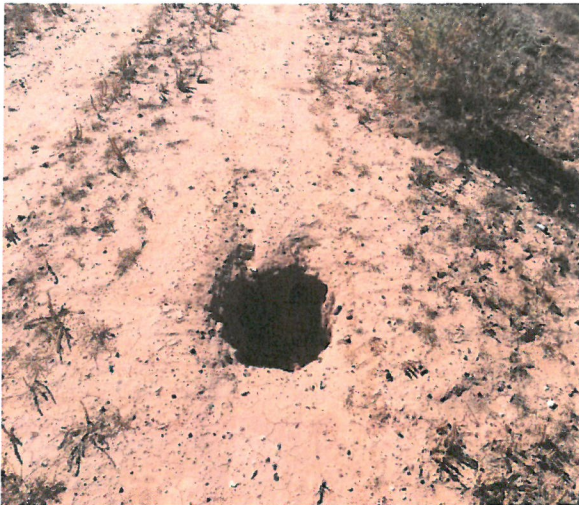
**Photograph 5:** Sinkhole H-2 about 18 inches in diameter along crest of embankment.

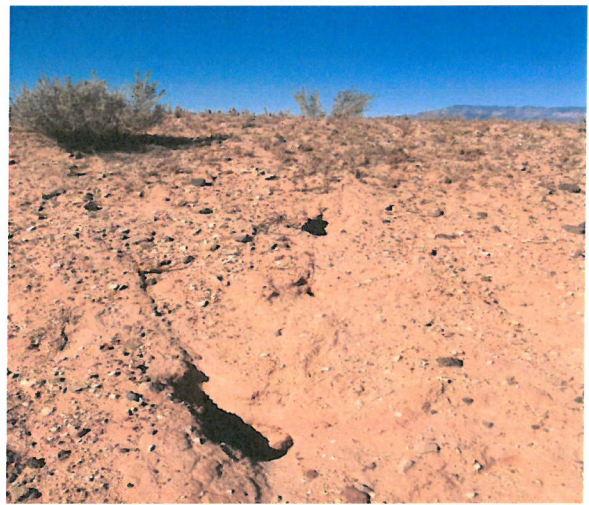
**Photograph 6:** Crack about 5 inches wide along upstream embankment; view to north.

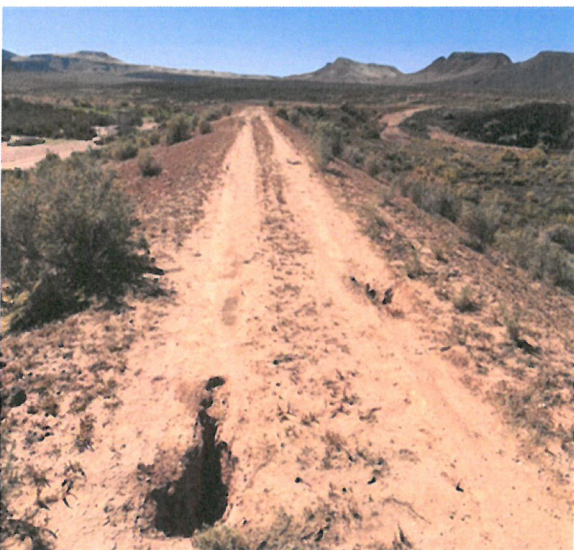
**Photograph 7:** Sinkholes H-6 & H-5 up to 18 inches wide along crest of embankment; view to north.

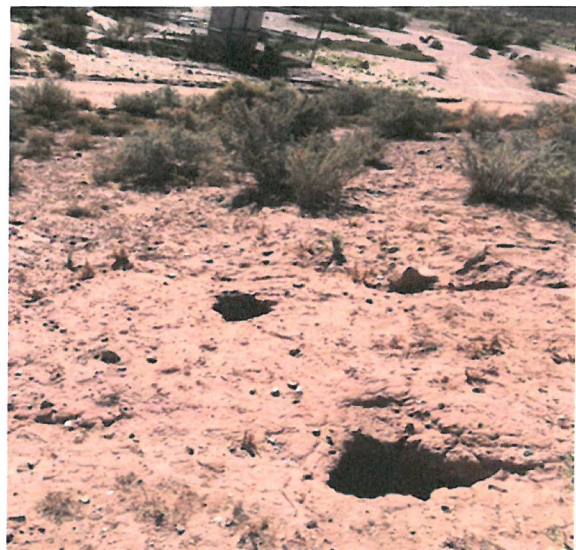
**Photograph 8:** Several sinkholes 13 to 22 inches in diameter along upstream slope (such as H-43 –H-45).

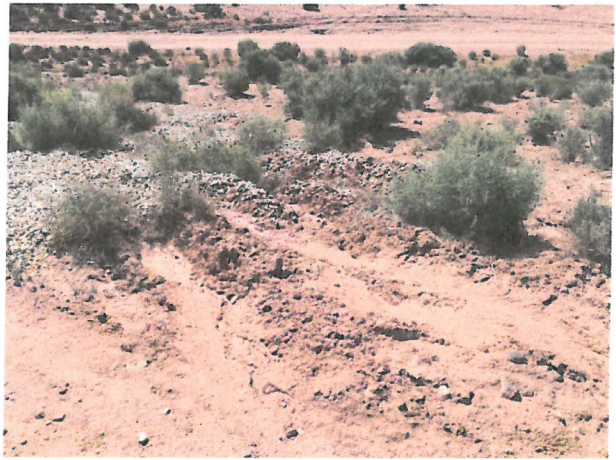
**Photo D.1-7** - Vehicle damage on upstream slope of dam.

4. Areas exhibiting rutting from vehicular/ATV activities, and/or erosion from surface runoff, should be repaired and stabilized.
5. ATV activities on the embankment and dike should be prohibited (i.e. signs, fencing, barriers, etc.).

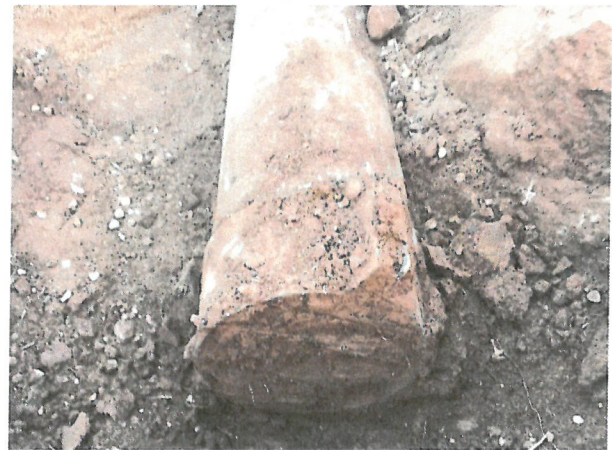
2. The two chimney drain outlet pipes were plugged with sediment. Plugged outlet pipes will not function as designed and may ultimately result in uncontrolled seepage through the dam, seepage around the drains, and possible localized piping and/or slump failures within the embankment. The plugged outlet pipes require timely remediation.

**Photo D.1-43** – Southern Chimney Drain Outlet location: Looking towards dam. Outlet was found to be full of sediment.

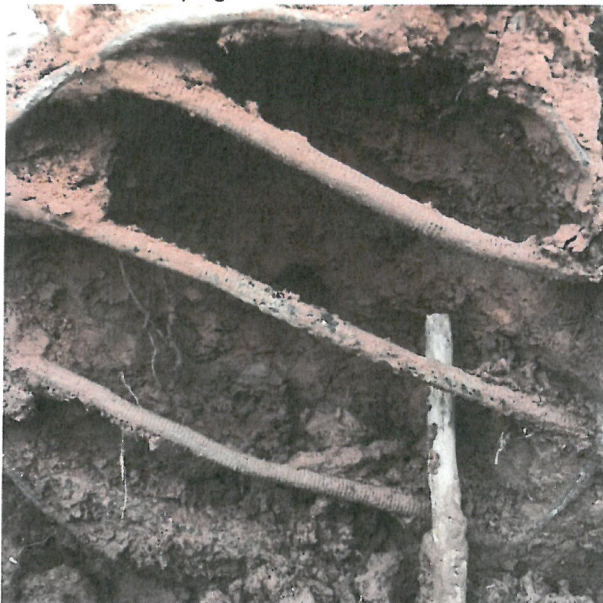
**Photo D.1-44** – Southern Chimney Drain Outlet location: Sediment within outlet extends more than 6" into pipe.

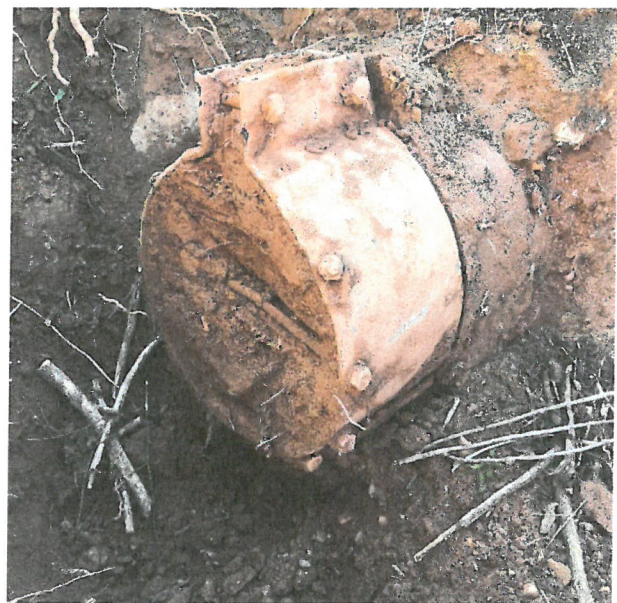
**Photo D.1-45** – Northern Chimney Drain Outlet location: Looking northeast. Outlet was found to be full of sediment.

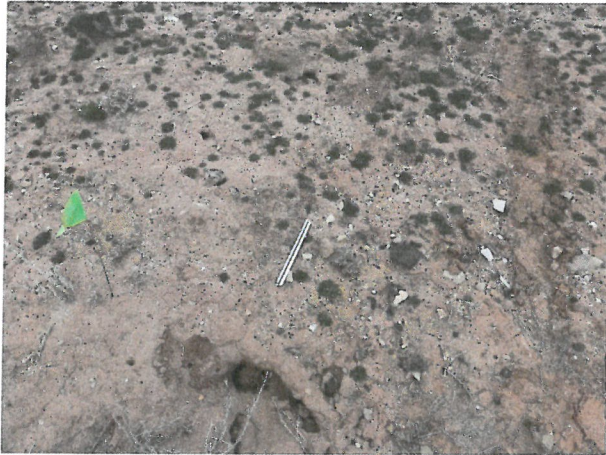
**Photo D.2-A1-1** – T-1 location: Overlooking H-51 before exploration. H-51 consists of a large primary opening (low and center) and clusters of smaller secondary openings (high center).

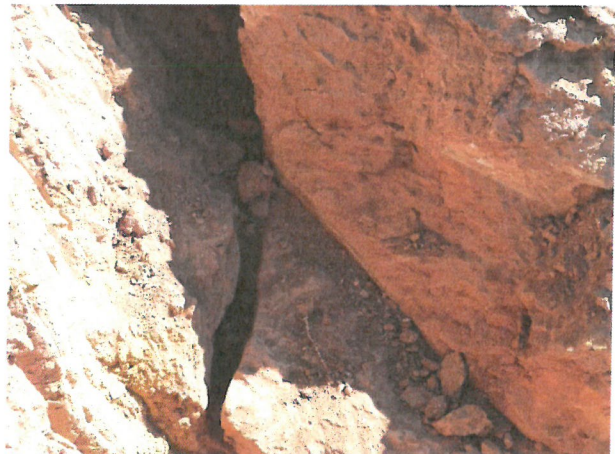
**Photo D.2-A1-4** – T-1 location: Looking northeast toward T-2, T-3, and T-4 along longitudinal crack in floor and northeast wall.

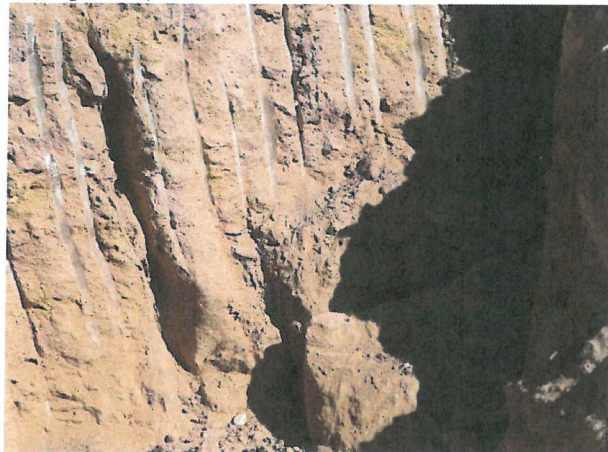
**Photo D.2-A1-5** – T-1 location: Looking north at intersection between longitudinal crack (left to right) and transverse crack in northwest wall (center left).

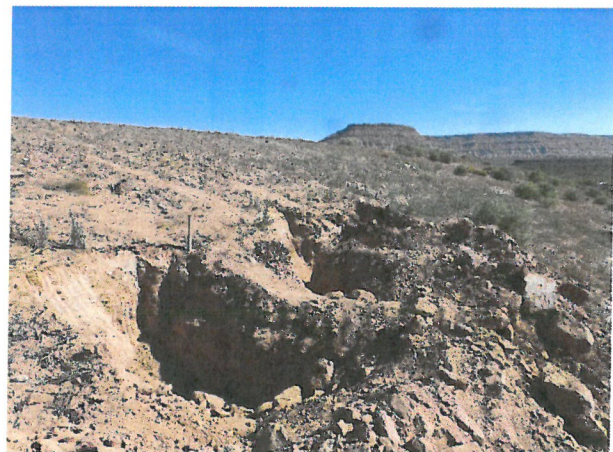
**Photo D.2-A1-6** – T-2 location: Longitudinal crack is located in northeast wall of T-2 directly below wood stake (center left).

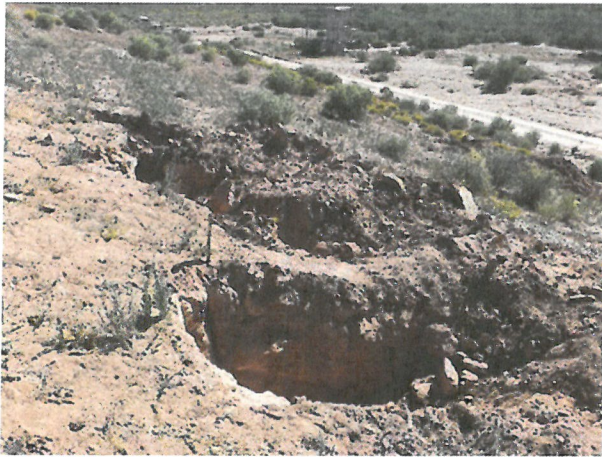
**Photo D.2-A1-7** - T-2 location: Looking northeast along general northeasterly direction of the longitudinal crack. Longitudinal crack is located in northeast wall of T-2 directly below wood stake (center left).

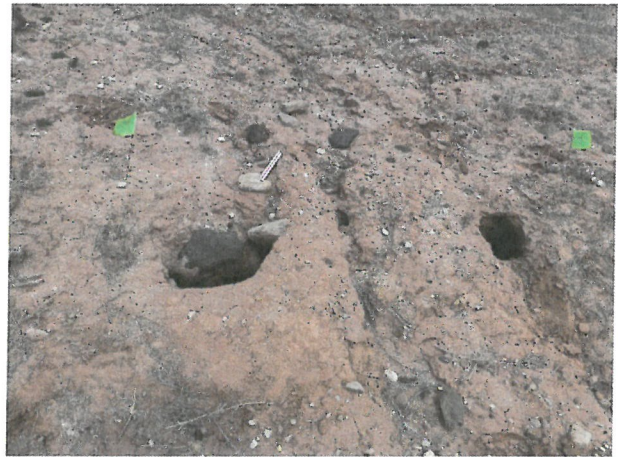
**Photo D.2-A1-8** – T-3 location: Overlooking H-50 (left) and H-49 (right) before exploration. H-49 and H-50 consisted of two separate openings in same crack. Large rocks had been placed over the opening and dirt had been deposited over top.

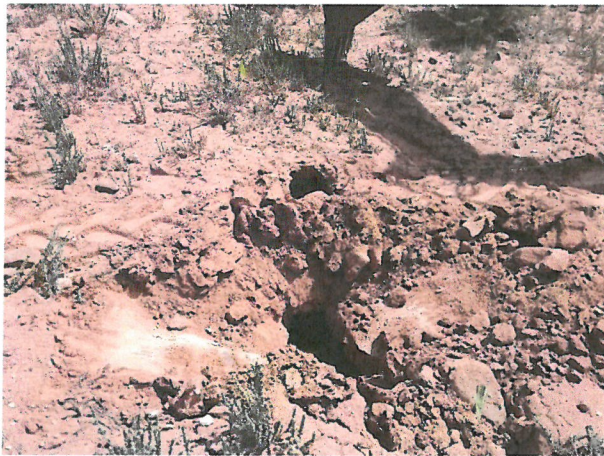
**Photo D.2-A1-9** – T-3 location: Overlooking H-50 (foreground) and H-49 (background) during exploration. Rocks have been removed to show general openness of the crack at the surface. A shallow dirt bridge still spans the crack between H-49 and H-50.

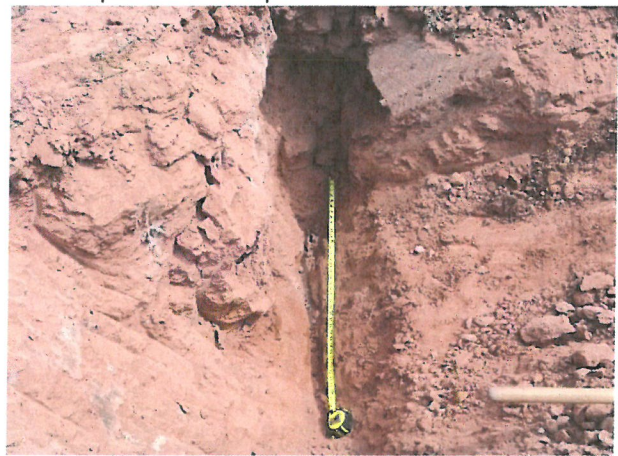
**Photo D.2-A1-10** – T-3 location: Looking northeast toward T-4 along longitudinal crack in floor and northeast wall.

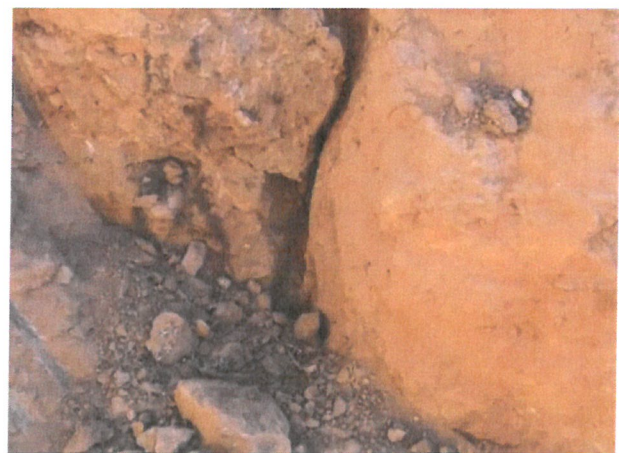
**Photo D.2-A1-12** – T-4 location: Looking northeast along the upstream side of the dam showing longitudinal crack in northeast wall.

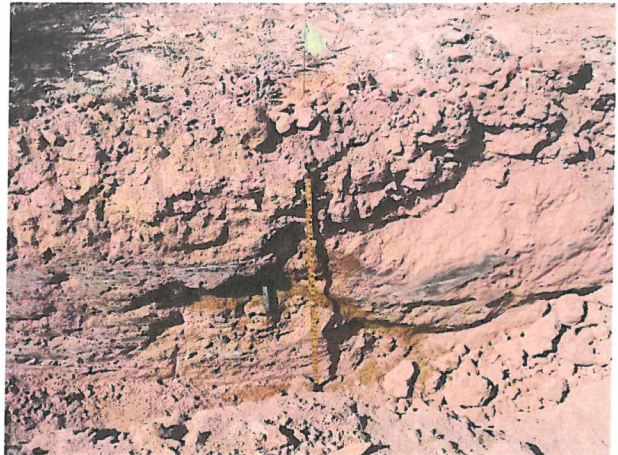
**Photo D.2-A2-2** – T-5 location: Looking northwest into trench at staining on northwest wall. An approximate 10-inch diameter hole into chimney drain material is located center photo.

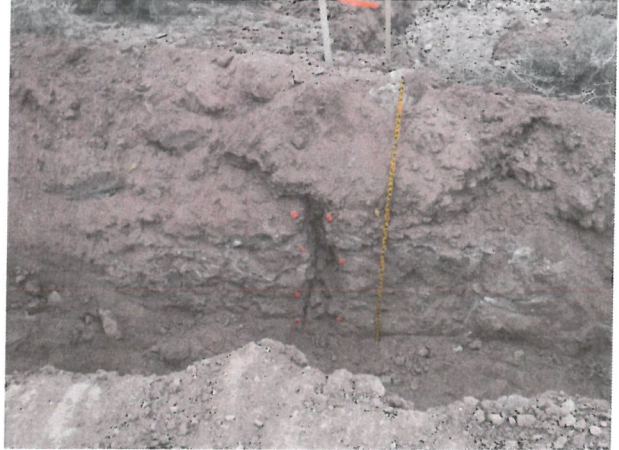
**Photo D.2-A2-8** – T-12 location: Looking northwest into trench at continuation of crack through northwest wall.

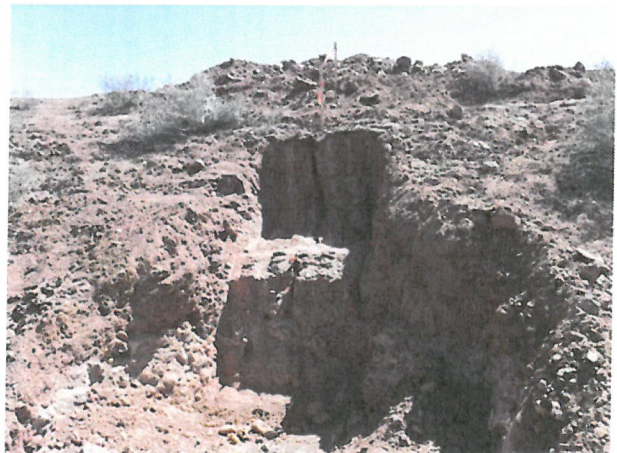
**Photo D.2-A2-10** – T-15 location: Looking southeast towards T-12. One transverse crack can be observed in the upper wall and two in the lower wall of T-15. Flagged lath in the background shows the alignment with the same crack observed in T-12.

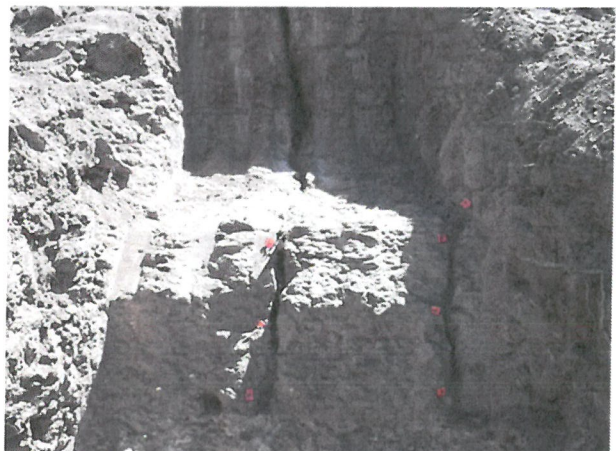
**Photo D.2-A2-12** – T-15 location: Looking southeast along the primary transverse crack in the floor between the upper and lower walls of T-15. The secondary crack can be observed in the lower right corner of the photo. Both cracks end at the old embankment material.

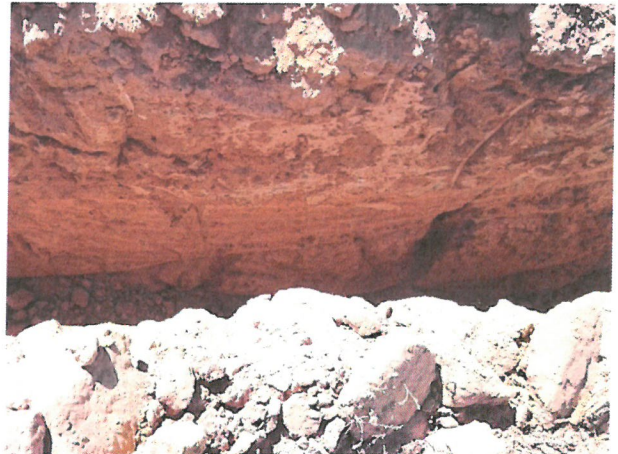
**Photo D.2-A3-2** – T-7 location: Looking southeast into trench. An open crack can be observed in southeast wall.

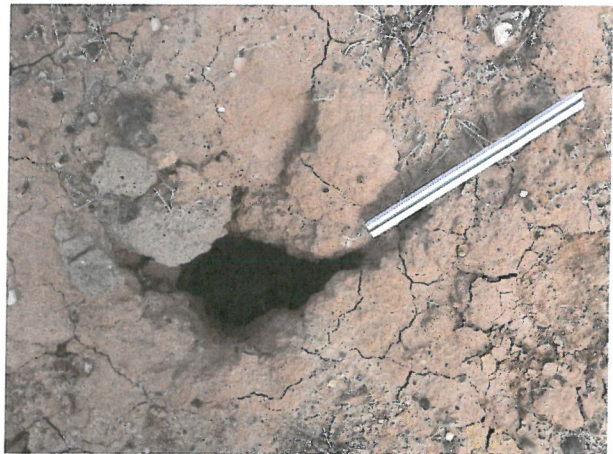
**Photo D.2-A3-4** – T-8 location: Looking overlooking H-11 prior to exploration. Remnants of grout from previous maintenance attempts can be observed at the surface.

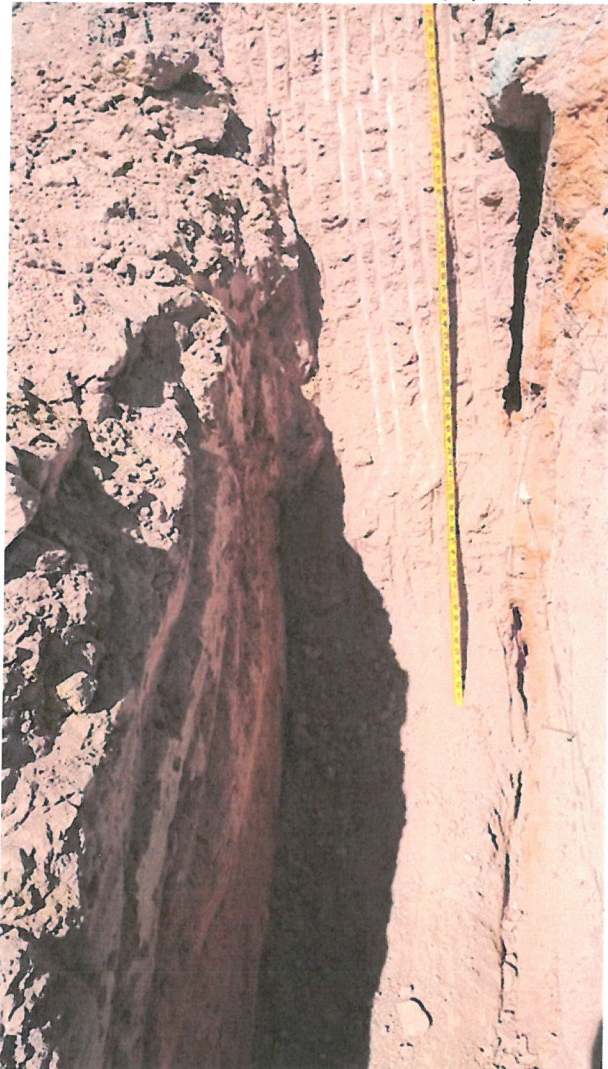
**Photo D.2-A3-9** – T-8 location: Looking northwest after excavation was completed. An open crack can be observed in the northwest wall below grout cap, and in the floor of trench.

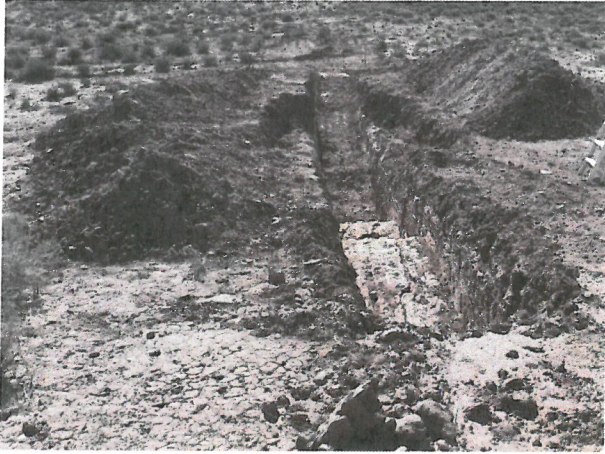
**Photo D.2-A3-10** – T-13 location: Looking southeast into the trench from the upstream side of the embankment. Transverse cracking is visible in the floor of the trench.

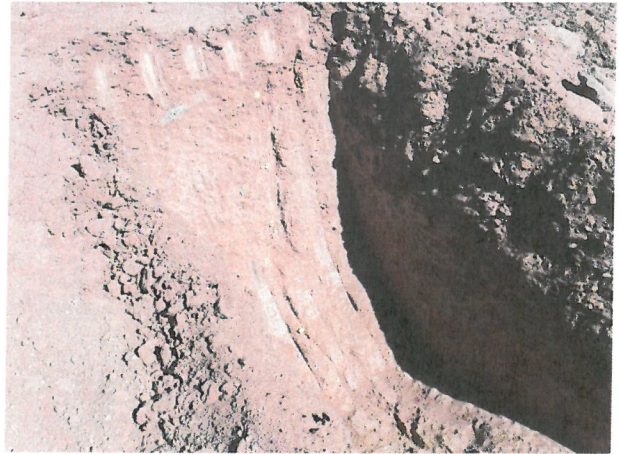
**Photo D.2-A3-11** – T-13 location: Looking northwest into trench at the crack located in the upper northwest wall.

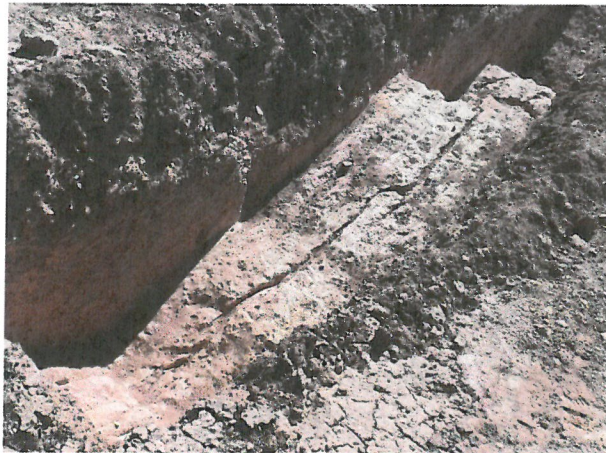
**Photo D.2-A3-11** – T-13 location: Looking northeast into trench at the crack located in the floor of the upper bench.

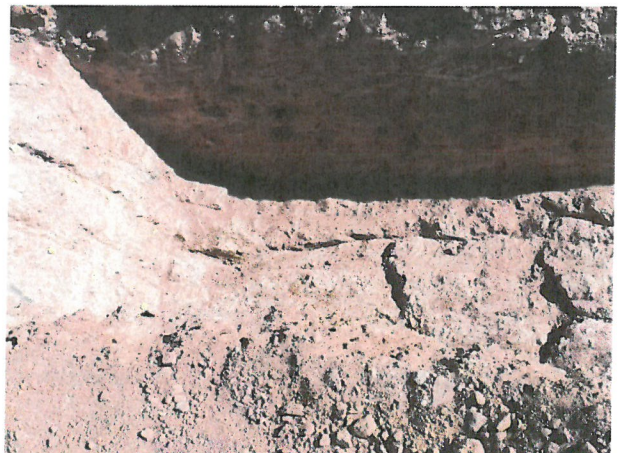
**Photo D.2-A3-12** – T-13 location: Looking northeast into trench at the two cracks located in the wall of the middle bench and their continuation further downstream in the floor of the middle bench.

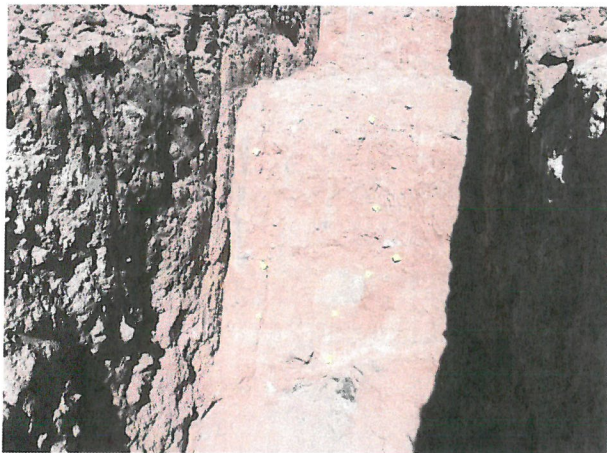
**Photo D.2-A3-13** – T-13 location: Looking northwest along T-13 showing the continuation of two cracks into the lower wall, and finally terminating at the underlying basalt formation

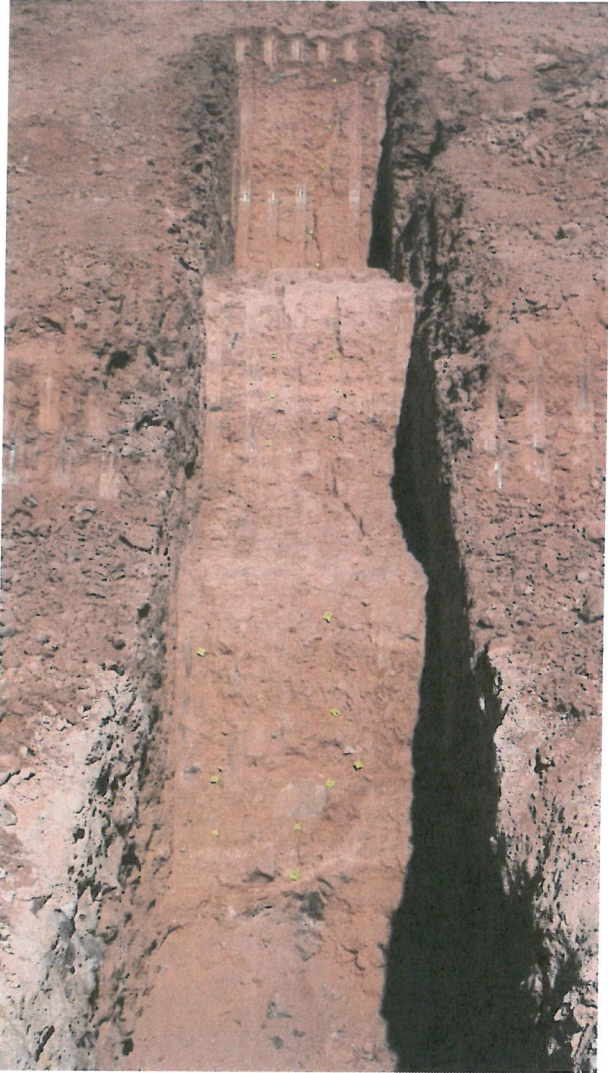
**Photo D.2-A3-14** – T-13 location: Looking northwest along T-13 showing the continuation of two cracks into the lower walls, and finally terminating at the underlying basalt formation

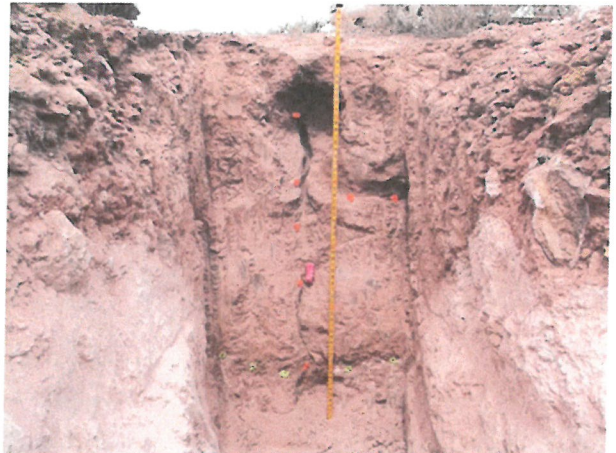
**Photo D.2-A4-8** – T-11 location: Looking northwest. A transverse crack can be observed in the northwest wall and a 3 inch hole intersecting the crack and running longitudinally in a northeasterly direction along the dam.

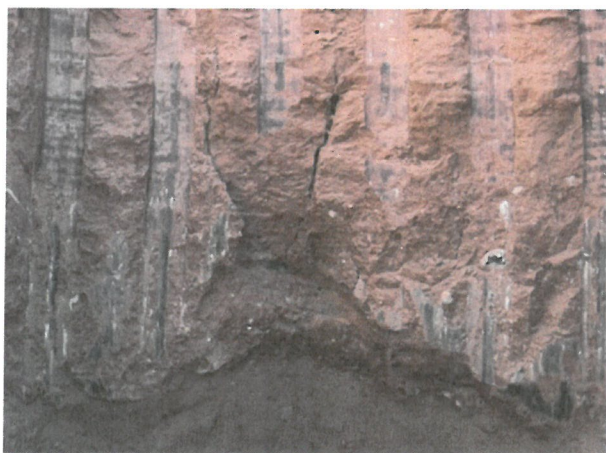
**Photo D.2-A5-5** – T-14 close up of crack in southeast wall.

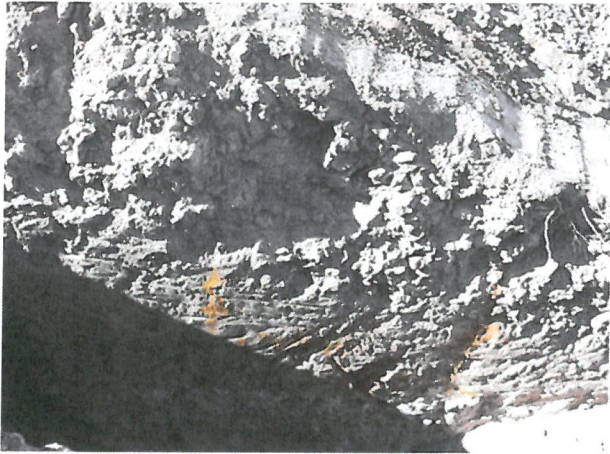
**Photo D.2-A5-7** – T-14 location: Looking southwest down into trench at the southwest wall. Staining carried by longitudinal and transverse cracks can be seen on the wall.

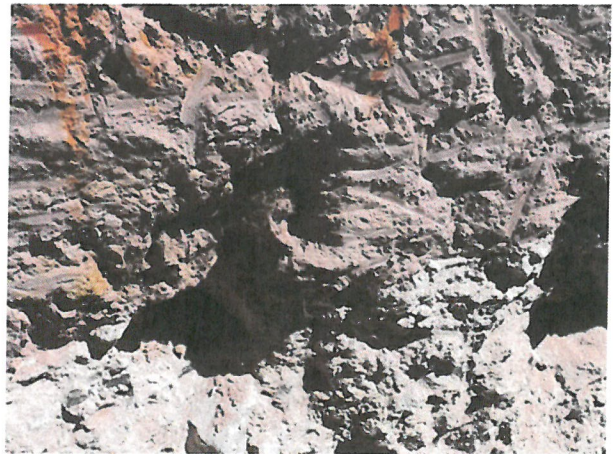
**Photo D.2-A5-8** – T-14 location: Looking southwest at the southwest wall. Died cracks can be observed in the new embankment terminating at the old embankment interaction

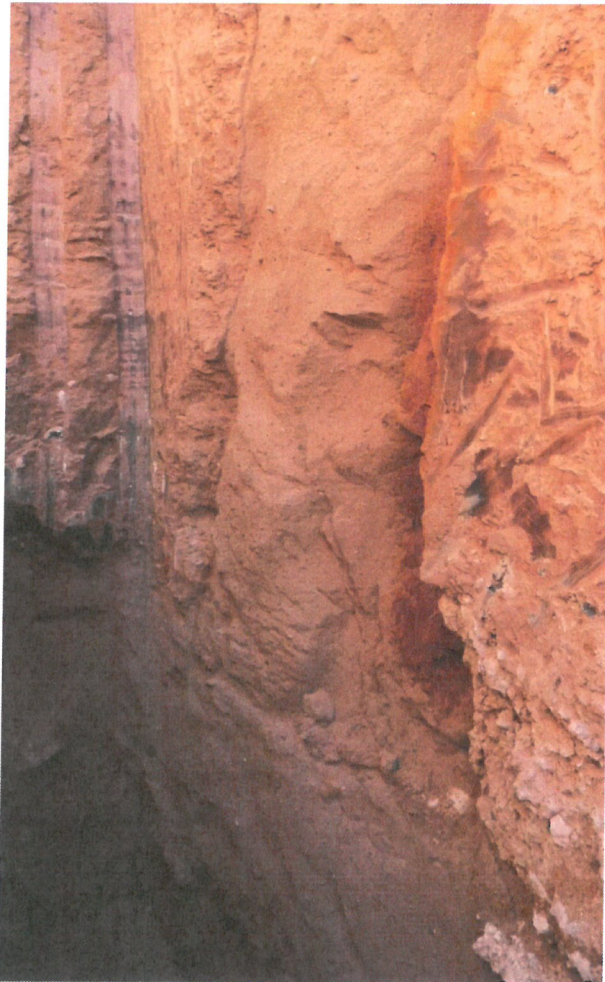
**Photo D.2-A5-9** – T-8 location: Looking at the staining in the southwest wall along the chimney drain embankment interaction from the presoaking of holes H-34 & H-35.
