# **GEOTECHNICAL EVALUATIONS/FIELD SUVEYING SERVICES/ DISTRESS SINKHOLE & CRACKING EVALUATIONS**

Frog Hollow Dam (UT00418)  
Washington County, Utah

RA Project No. 8384-14-008  
June 27, 2016

**Subject: Geotechnical Evaluations / Field Surveying Services /  
Distress Sinkhole & Cracking Evaluations**  
Frog Hollow Dam (UT00418), Washington County, Utah  
RA Project No. 8384-14-008

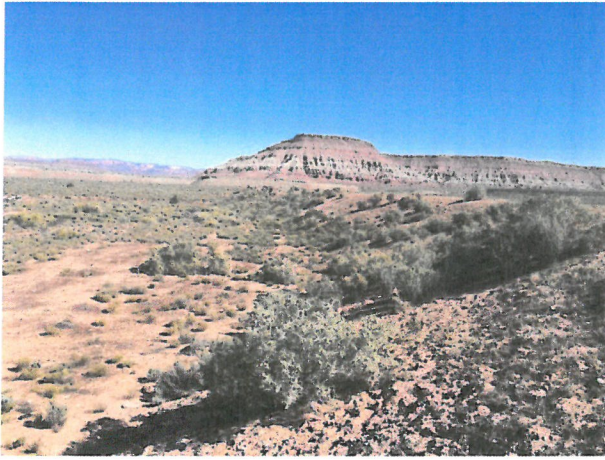
**Photo D.1-18** Looking northeast along the downstream slope of the dam, knee-high vegetation.

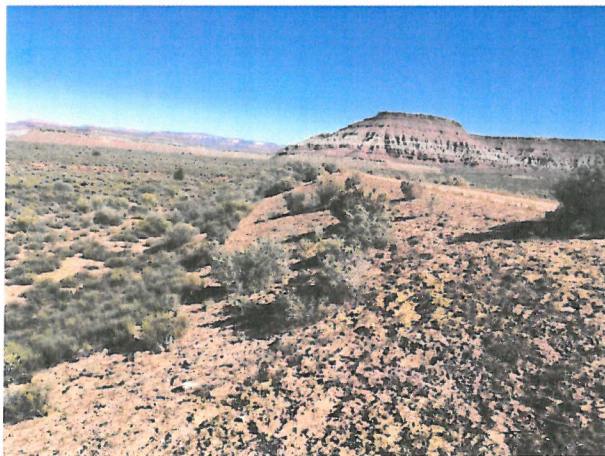
**Photo D.1-22** Looking northeast along the downstream slope of the dam, knee-high vegetation.

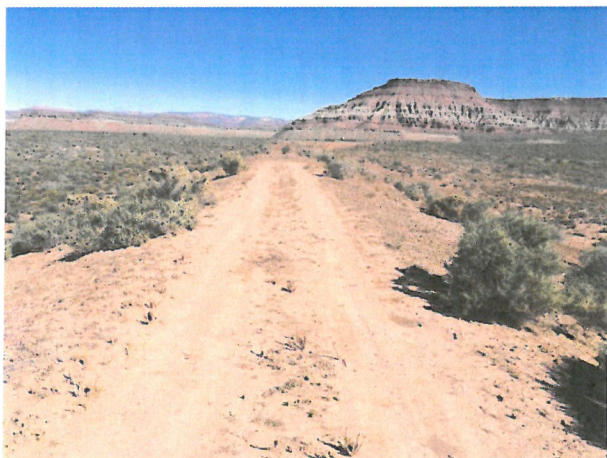
**Photo D.1-26** Looking northeast along the center of the dam, knee-high vegetation.

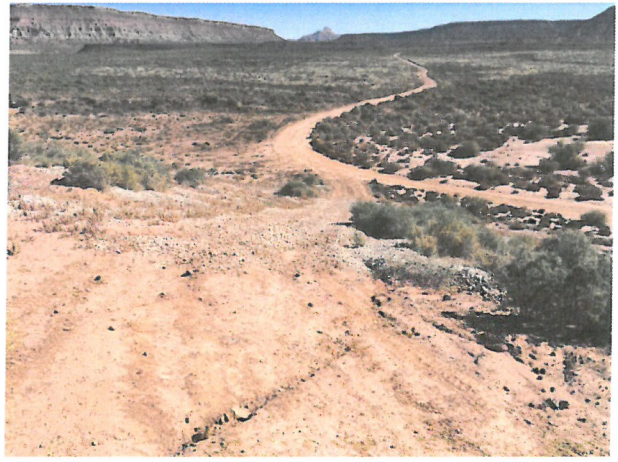
**Photo D.1-31** Vehicle tracks climbing up dam on upstream slope.

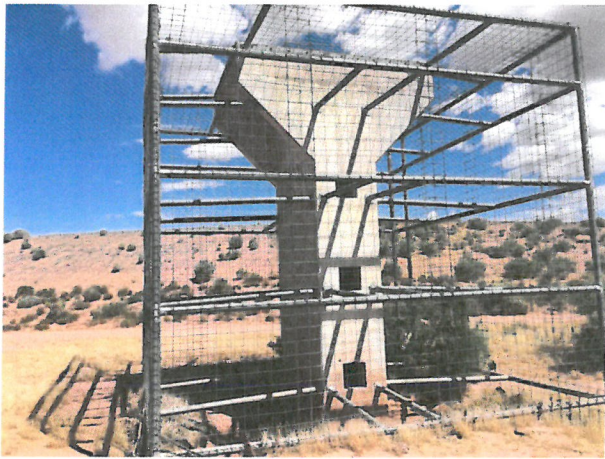
**Photo D.1-32** Southeast face of drainage structure, two openings below ground-surface elevation.

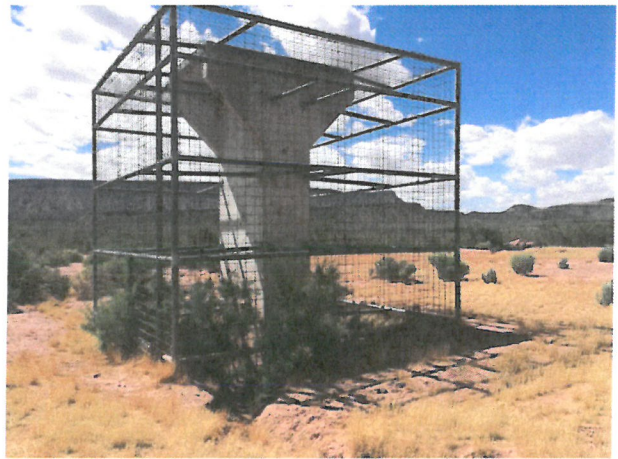
**Photo D.1-33** Northwest face of drainage structure, vegetation in cage.

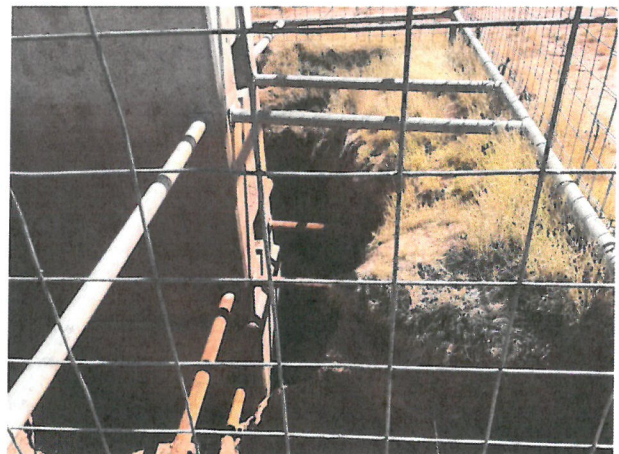
**Photo D.1-35** Sediment buildup and erosion at southeast face of drainage structure.

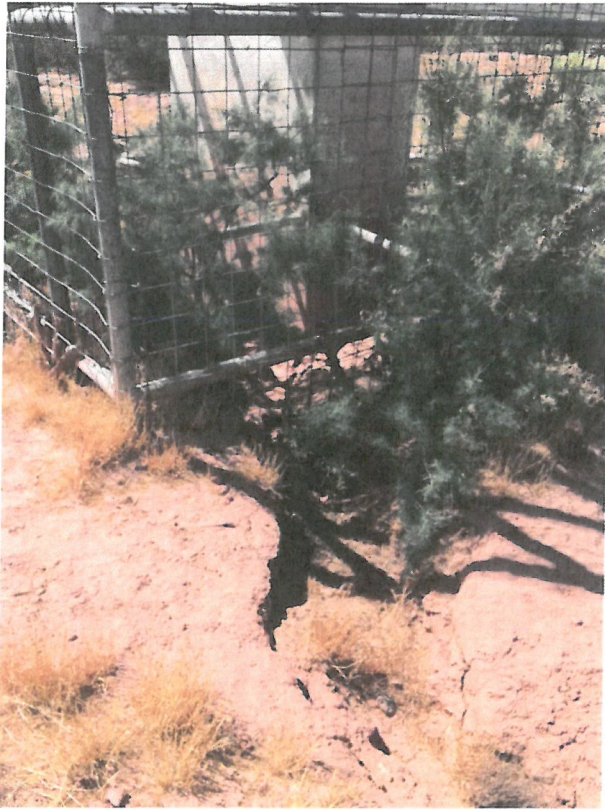
**Photo D.1-36** Erosion at north corner of drainage structure, vegetation in cage.

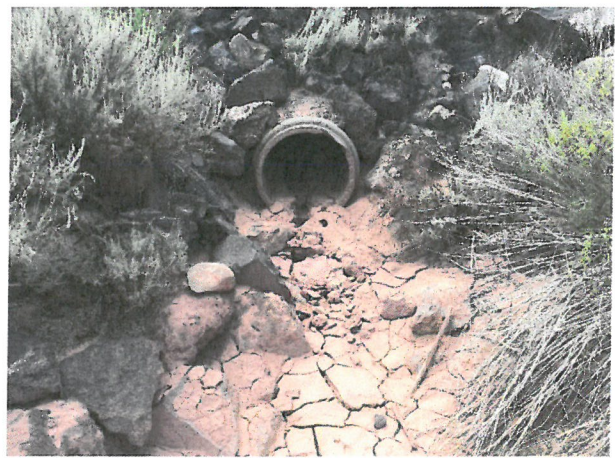
**Photo D.1-39** – Principal Outlet location: Looking towards dam along principal outlet prior to any excavation.

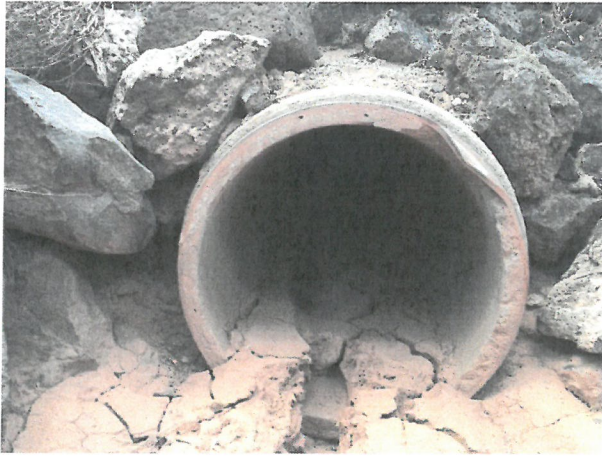
**Photo D.1-40** – Principal Outlet location: Looking towards dam along outlet. Sedimentation is apparent in the principal outlet pipe.

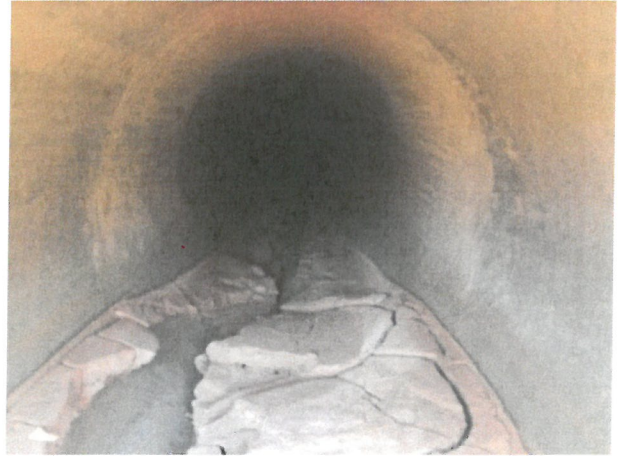
**Photo D.1-41** – Principal Outlet location: Looking towards dam into principal outlet. Sedimentation extends back into outlet pipe.

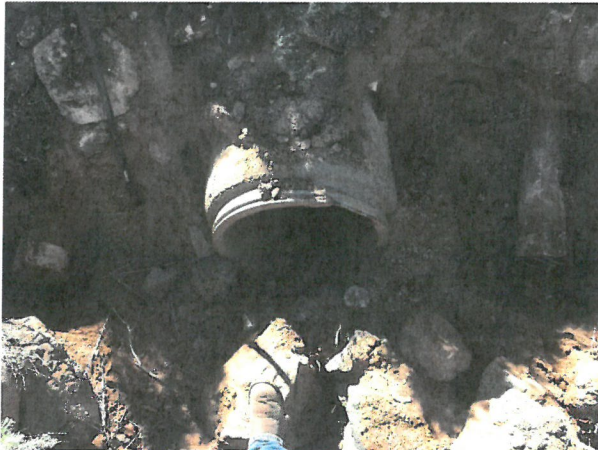
**Photo D.1-42** – Principal Outlet location: Looking towards dam down at outlet after exposing chimney drain outlet pipes. One chimney drain outlet pipe is located on each side of the principal outlet pipe; Found at 24" below slope grade.

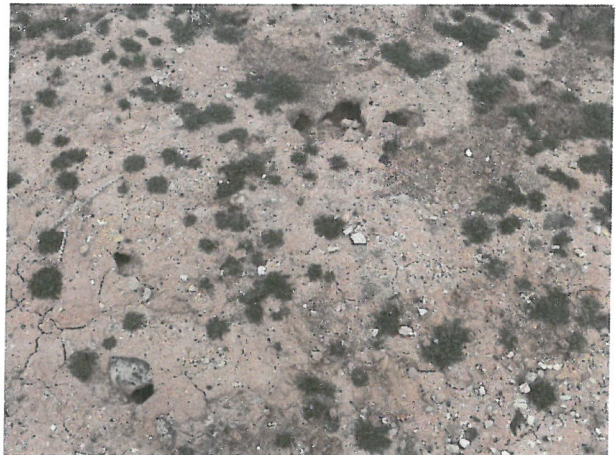
**Photo D.2-A1-2** – T-1 location: Overlooking H-51 secondary openings before exploration.

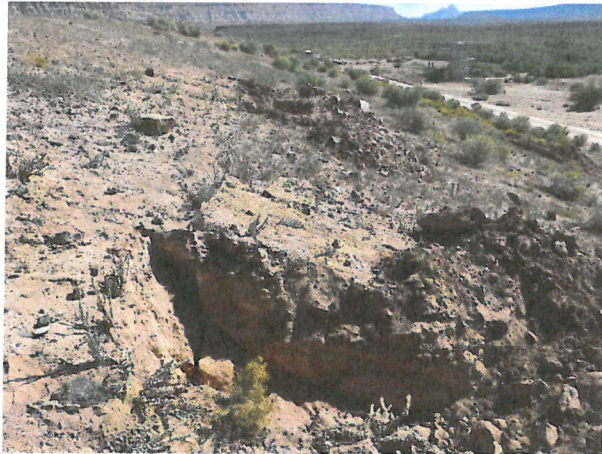
**Photo D.2-A1-3** – Overlooking Area 1. Looking northeast along the upstream slope of dam showing T-1 (foreground) in relation to T-2, T-3 and T-4 (background).

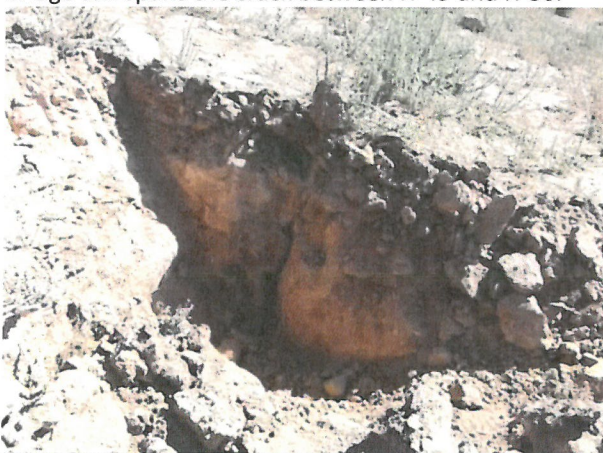
**Photo D.2-A1-11** – T-4 location: Looking northeast along the upstream side of the dam showing longitudinal crack in northeast wall.

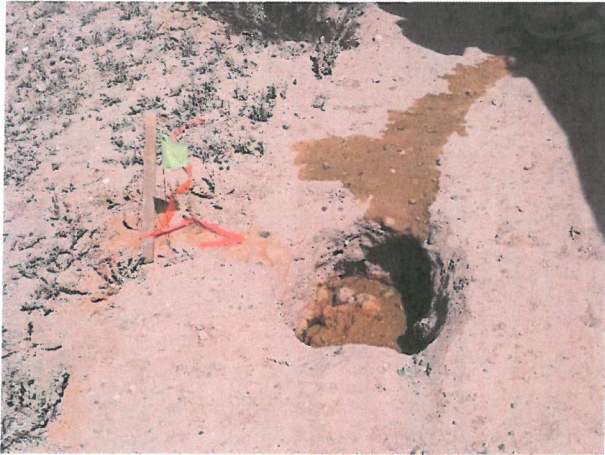
**Photo D.2-A2-1** – T-5 location: Looking northeast over H-2 after presoaking and staining prior to exploration.

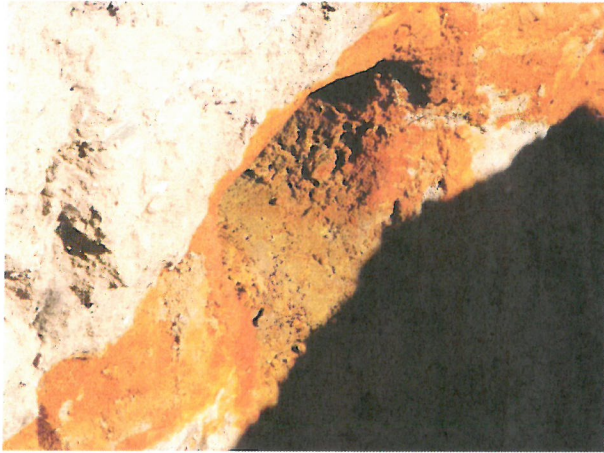
**Photo D.2-A2-3** – T-5 location: Looking northwest into trench at staining around 10-inch hole in chimney drain material located on the northwest wall.

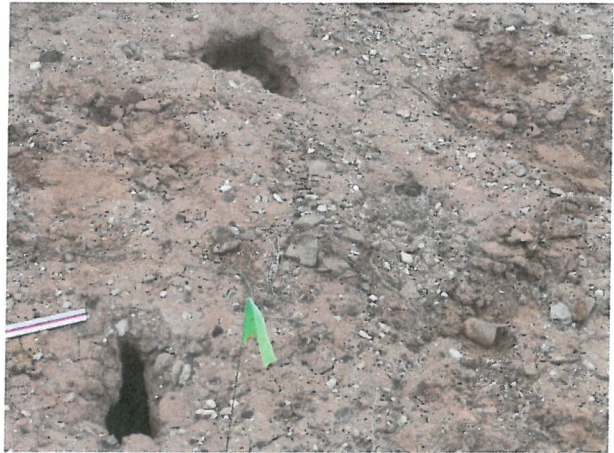
**Photo D.2-A2-4** – T-6 location: Looking northwest over H-4 (background) and H-3 (foreground) prior to exploration.

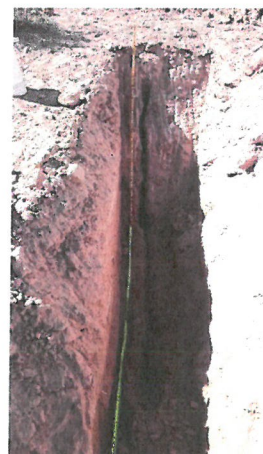
**Photo D.2-A2-6** – T-6 location: Looking northwest at the transverse crack can be observed in the northwest wall of T-6.

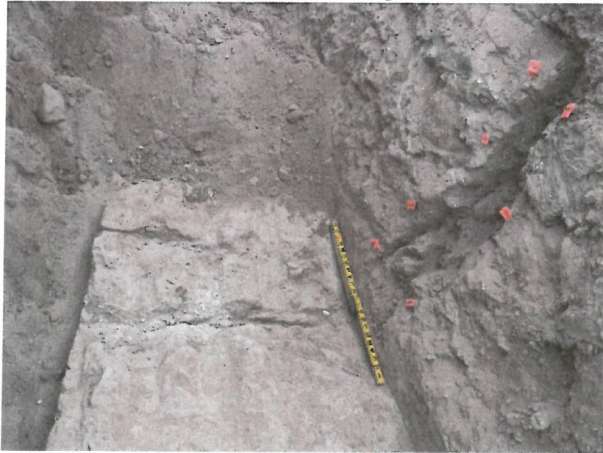
**Photo D.2-A2-9** – T-12 location: Looking southwest into trench at continuation of crack in floor through the chimney drain to the left to the downstream embankment to the right. Two separate crack are located in the floor of the trench and appear to converge in the northwest wall.

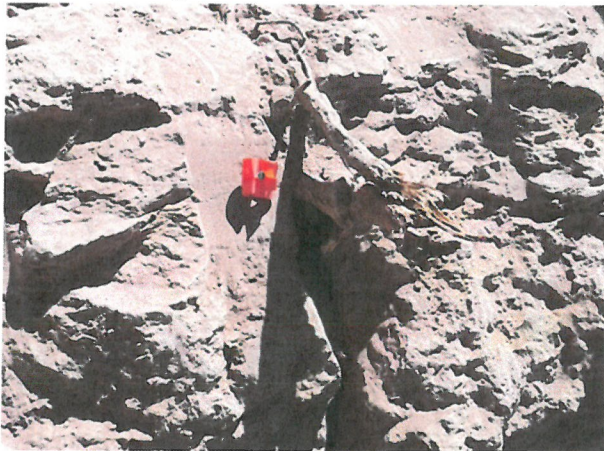
**Photo D.2-A2-11** – T-15 location: Looking southeast at the primary transverse crack in the lower wall of T-15. Roots can be observed within the primary crack.

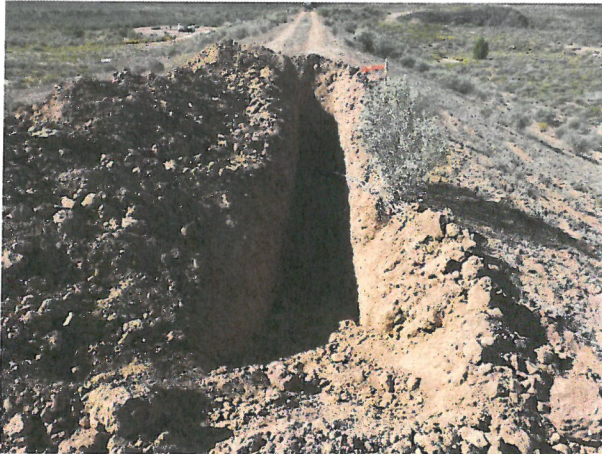
**Photo D.2-A3-1** – T-7 location: Looking southwest along dam crest.

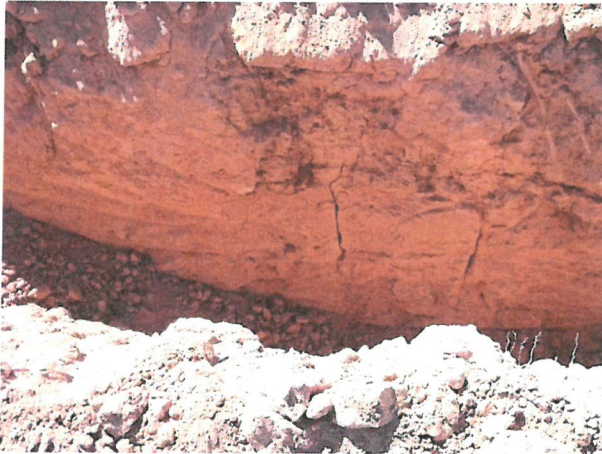
**Photo D.2-A3-3** – T-7 location: Looking southeast into trench. Multiple secondary crack can be observed in southeast wall.

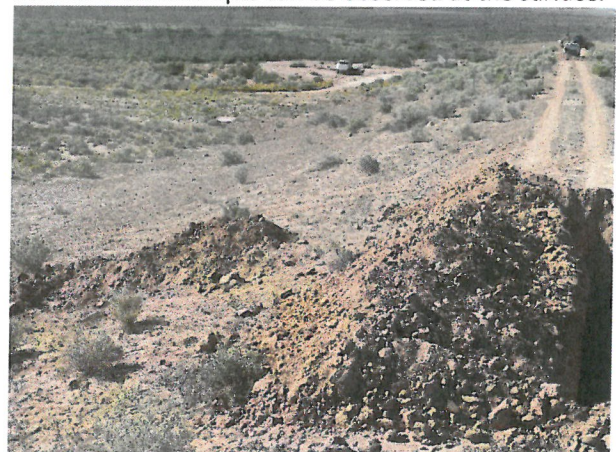
**Photo D.2-A3-6** – Area 3 location: Looking southwest over exploration T-7 and T-8. T-8 is located (left) on upstream slope and T-7 is located on dam crest (right)

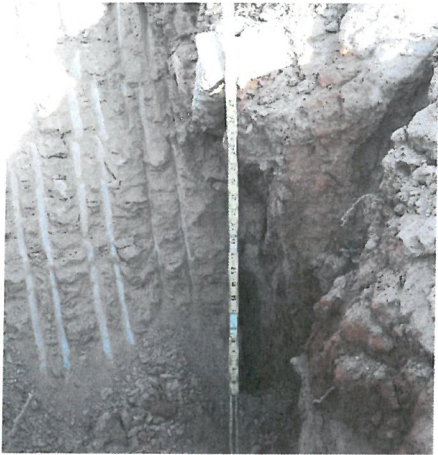
**Photo D.2-A3-7** – T-8 location: Looking northwest after 36 inches of excavation at H-11. A grout cap from previous maintenance attempts can be observed to end directly below the surface.

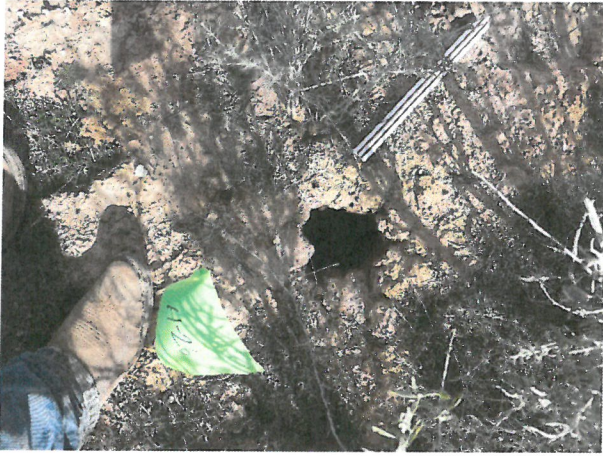
**Photo D.2-A4-1** – T-9 location: Overlooking H-26 prior to exploration.

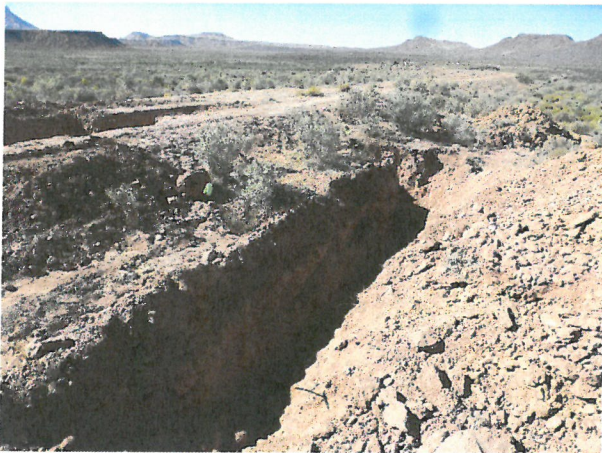
**Photo D.2-A4-3** – T-9 location: Looking south after exploration.

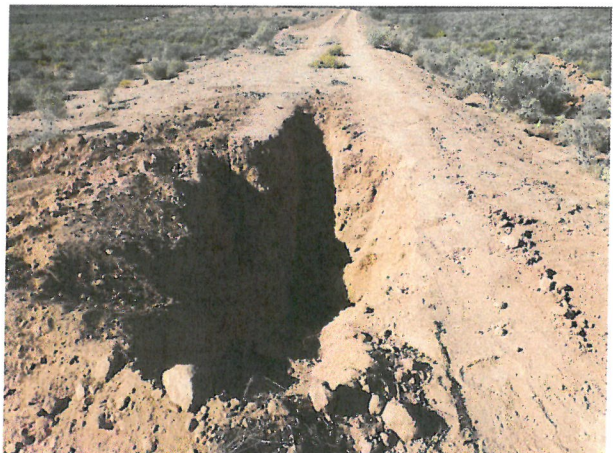
**Photo D.2-A4-4** – T-10 location: Looking southwest along dam crest.

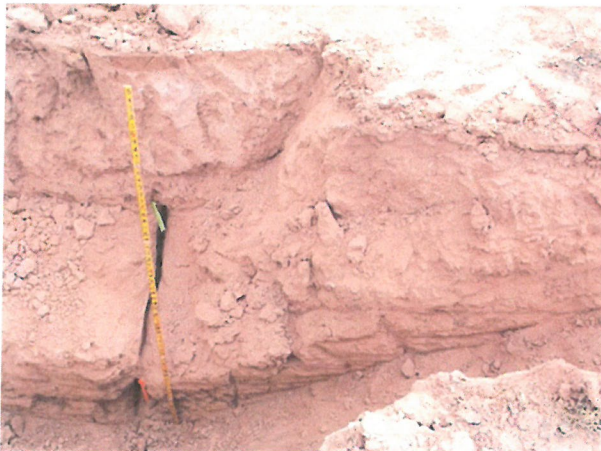
**Photo D.2-A4-5** – T-10 location: Looking southeast into trench. A transverse crack can be observed in the southeast wall.

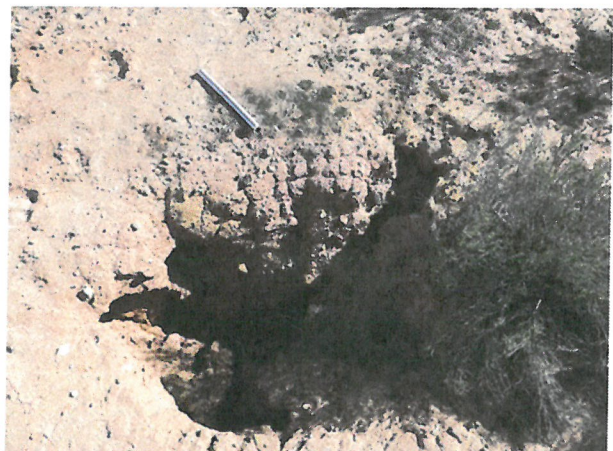
**Photo D.2-A4-6** – T-11 location: Overlooking H-20 prior to exploration.

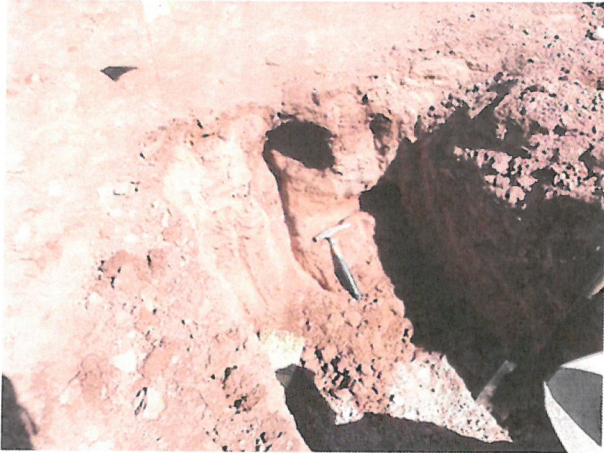
**Photo D.2-A4-7** – T-11 location: Looking north after 36 inches of excavation at H-20. Transverse crack can be observed in northwest wall.

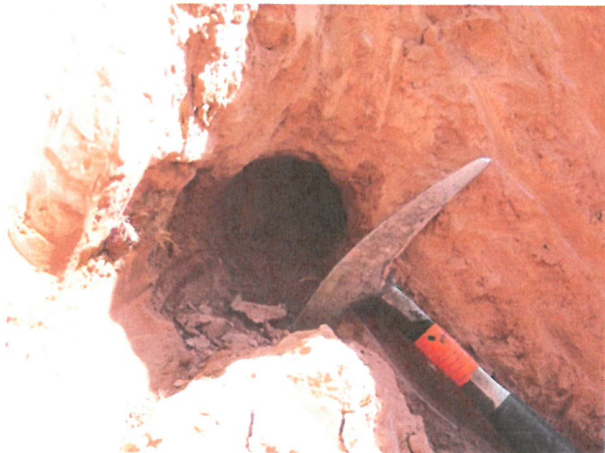
**Photo D.2-A4-9** – T-11 location: Looking northeast. 3 inch hole located in the northeast wall can be observed.

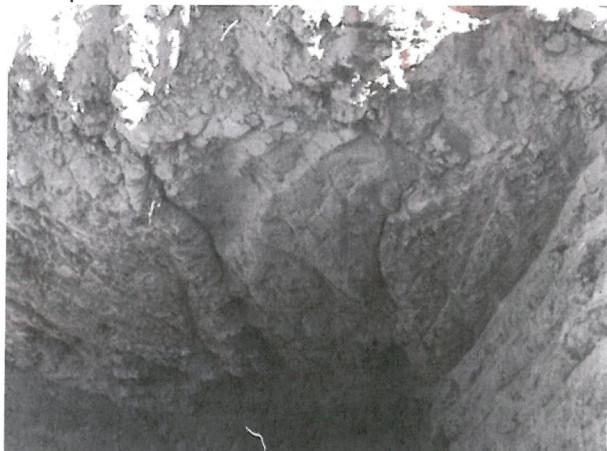
**Photo D.2-A5-3** – T-14 location: Looking northeast down into trench at the northeast wall. The chimney drain can be seen in the middle of the photo.

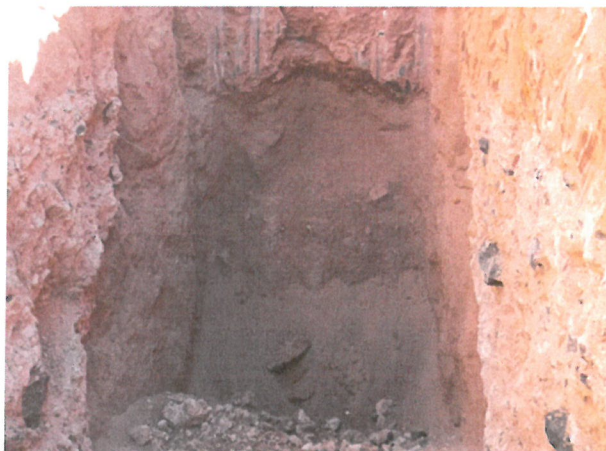
**Photo D.2-A5-4** – T-14 location: Looking southeast into embankment. A crack can be observed at the top middle of the photo at the interaction between the embankment material and the chimney drain.

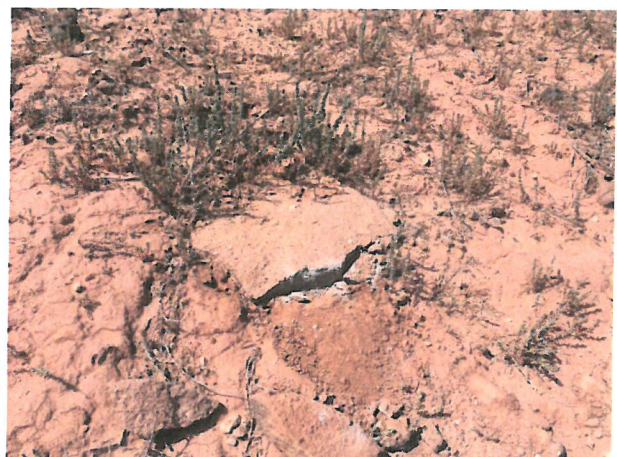
**Photo D.3-53** Hole H-51 (3.0'W x 6.0'L x 0.85'D)
