# **GEOTECHNICAL EVALUATIONS/FIELD SUVEYING SERVICES/ DISTRESS SINKHOLE & CRACKING EVALUATIONS**

Frog Hollow Dam (UT00418)  
Washington County, Utah

RA Project No. 8384-14-008  
June 27, 2016

**Subject: Geotechnical Evaluations / Field Surveying Services /  
Distress Sinkhole & Cracking Evaluations**  
Frog Hollow Dam (UT00418), Washington County, Utah  
RA Project No. 8384-14-008

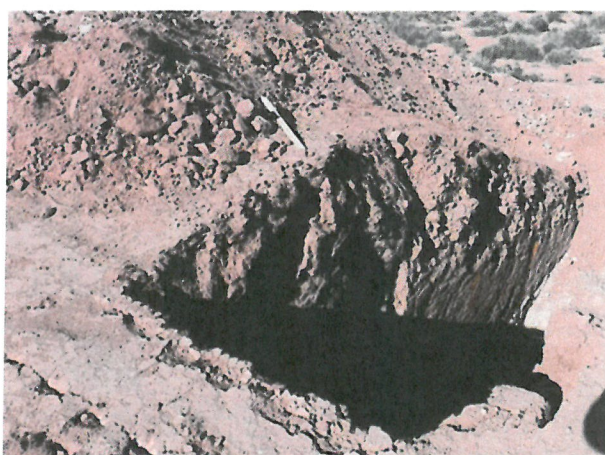
**Photo D.2-A5-2** – T-14 location: Looking southwest over T-14.

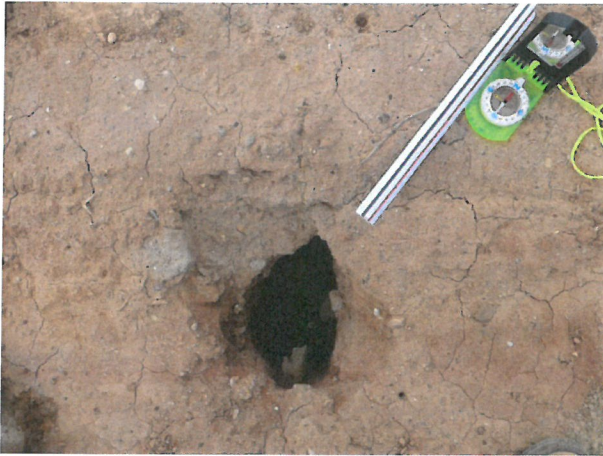
**Photo D.3-1** - Hole H-1 (0.45'Wide x 0.7'Long x 1.0' Depth)

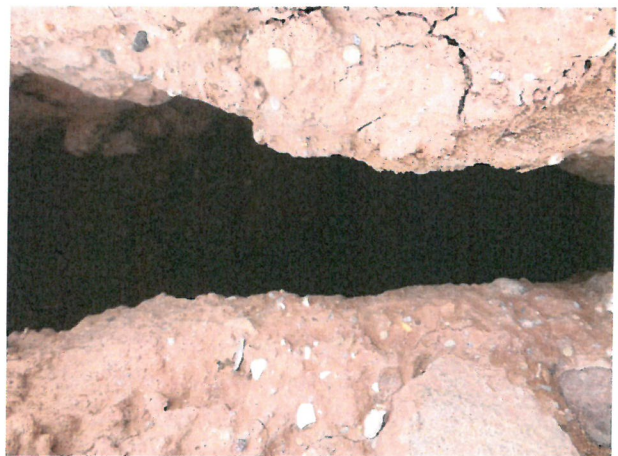
**Photo D.3-3** Hole H-3 (0.4'W x 1.1'L x 2.8'D)

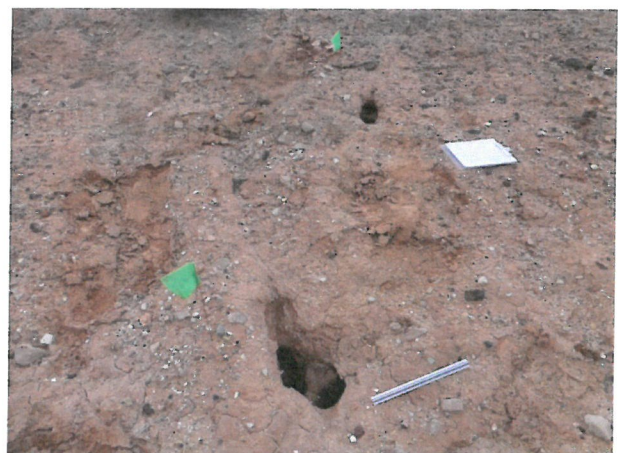
**Photo D.3-5** Hole H-3 (0.4'W x 1.1'L x 2.8'D)

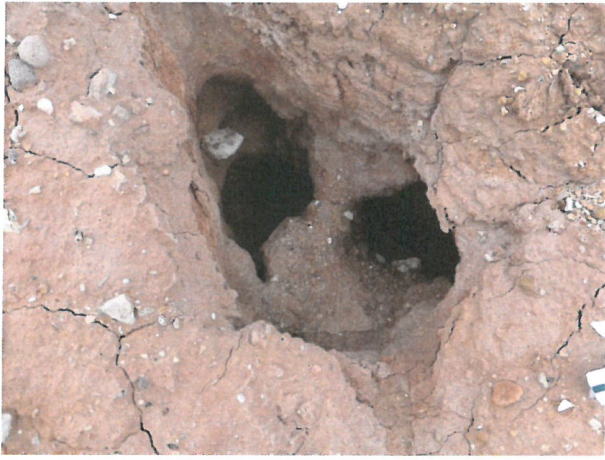
**Photo D.3-6** Hole H-4 (0.8'W x 1.6'L x 2.6'D)

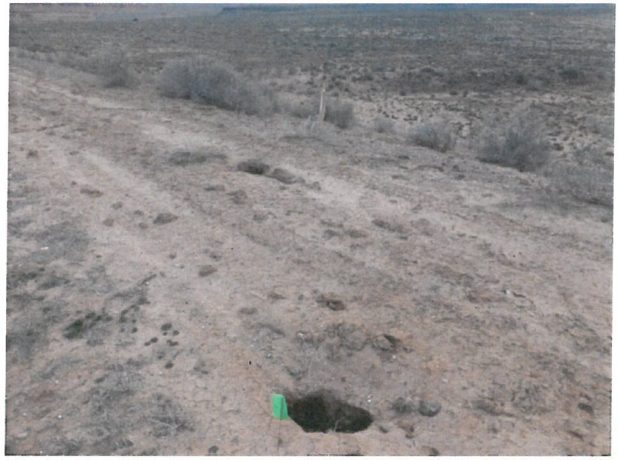
**Photo D.3-7** Hole H-4 (0.8'W x 1.6'L x 2.6'D)

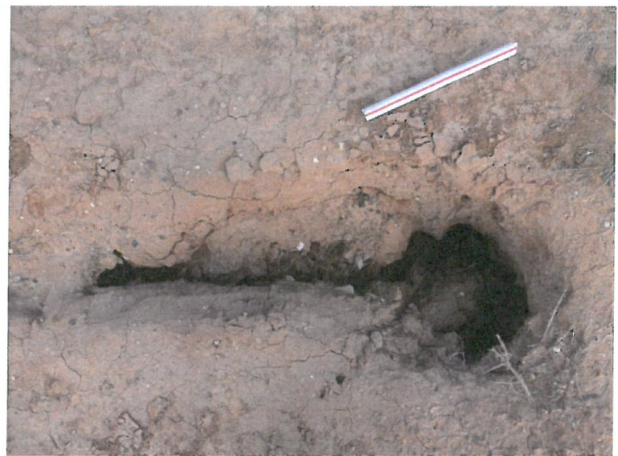
**Photo D.3-9** Hole H-5 (1.25'W x 1.6'L x 1.5'D)

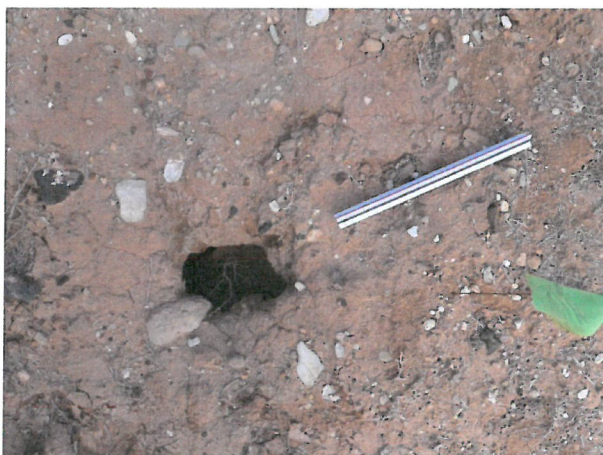
**Photo D.3-10** Hole H-6 (3.1'W x 1.6'L x 1.8'D)

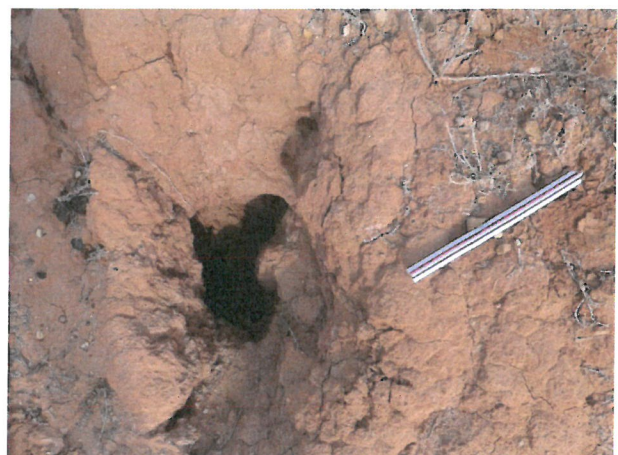
**Photo D.3-11** Hole H-7 (0.7'W x 0.5'L x 1.0'D)

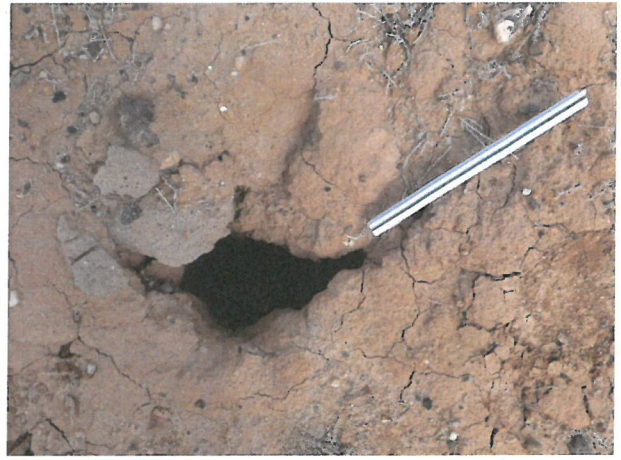
**Photo D.3-13** Hole H-10 (0.6'W x 0.65'L x 1.8'D)

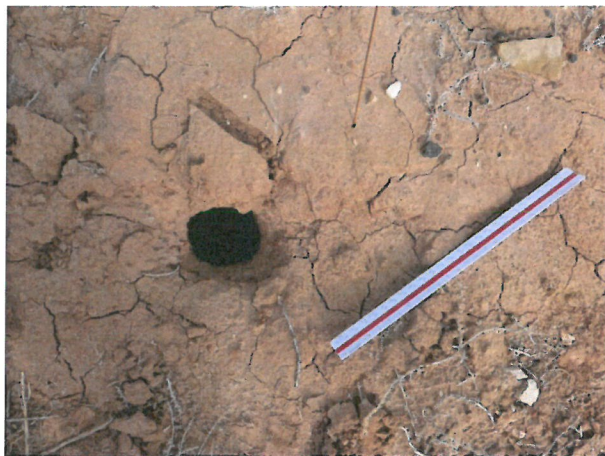
**Photo D.2-A3-4** – T-8 location: Looking overlooking H-11 prior to exploration. Remnants of grout from previous maintenance attempts can be observed at the surface.

**Photo D.2-A3-7** – T-8 location: Looking northwest after 36 inches of excavation at H-11. A grout cap from previous maintenance attempts can be observed to end directly below the surface.

**Photo D.2-A3-8** – T-8 location: Looking north after excavation was completed. Staining, outlined by string, can be observed on the northeast wall at H-11. A grout cap from previous maintenance attempts can be observed (top left).

**Photo D.2-A3-9** – T-8 location: Looking northwest after excavation was completed. An open crack can be observed in the northwest wall below grout cap, and in the floor of trench.

**Photo D.3-14** Hole H-11 (1.1'W x 0.9'L x 1.4'D)

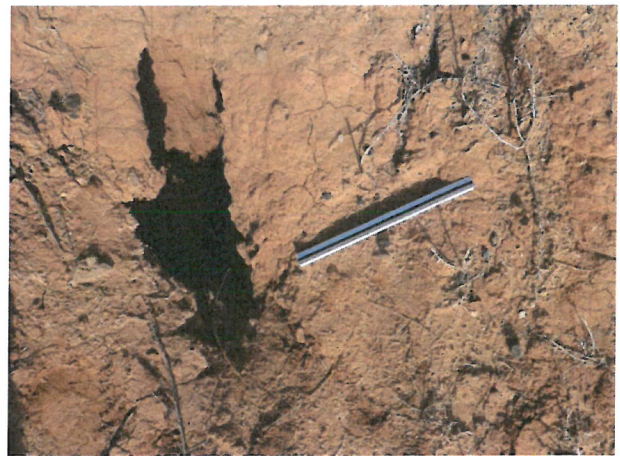
**Photo D.3-15** Hole H-12 (0.4'W x 0.35'L x 1.3'D)

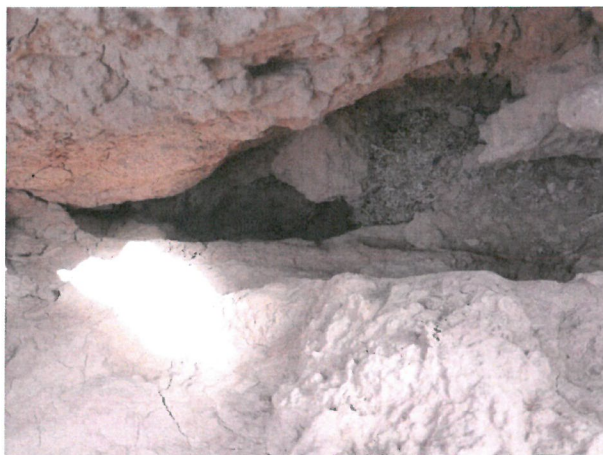
**Photo D.3-16** Hole H-13 (0.8'W x 1.8'L x 3.4'D)

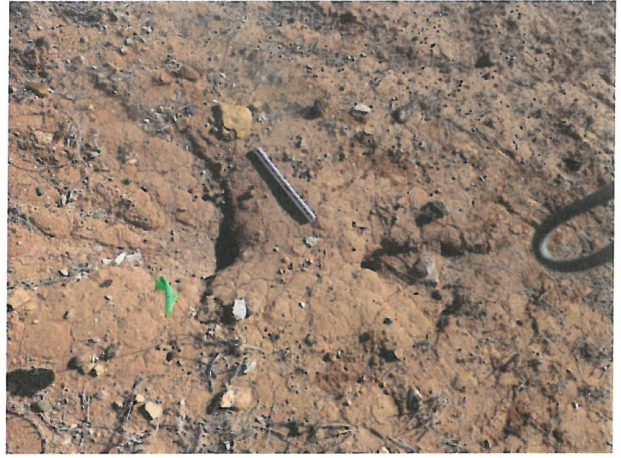
**Photo D.3-19** Hole H-15 (0.5'W x 0.65'L x 2.9'D)

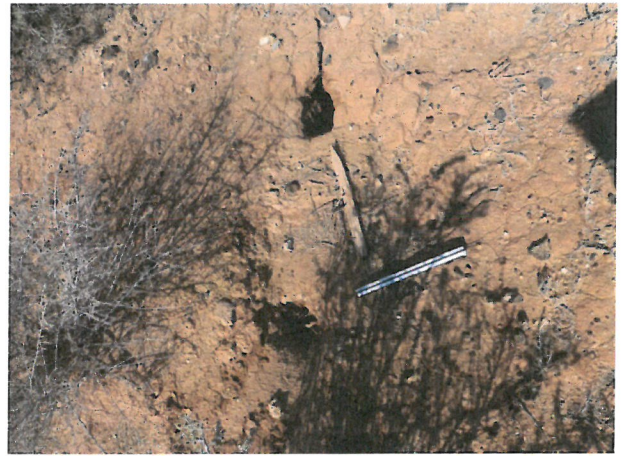
**Photo D.3-21** Hole H-17 (0.2'W x 0.5'L x 2.8'D)

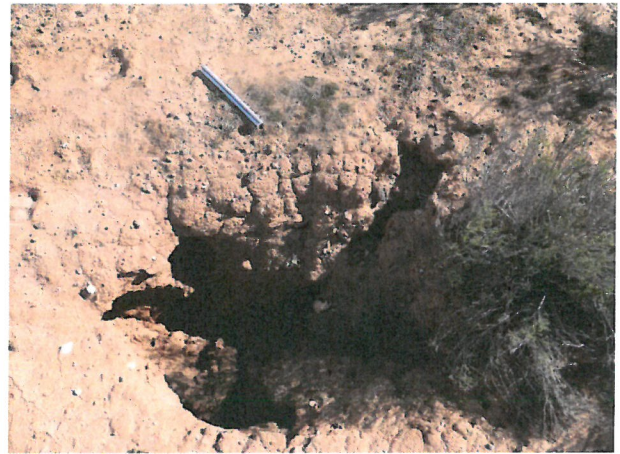
**Photo D.3-23** Hole H-19 (0.2'W x 0.3'L x 1.4'D)

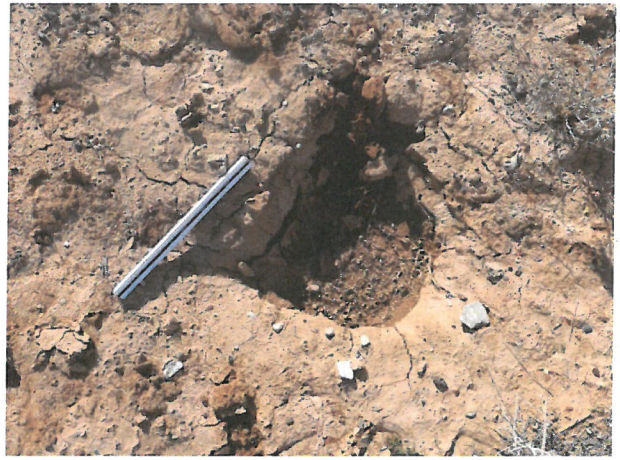
**Photo D.3-25** Hole H-21 (1.9'W x 2.2'L x 0.6'D)

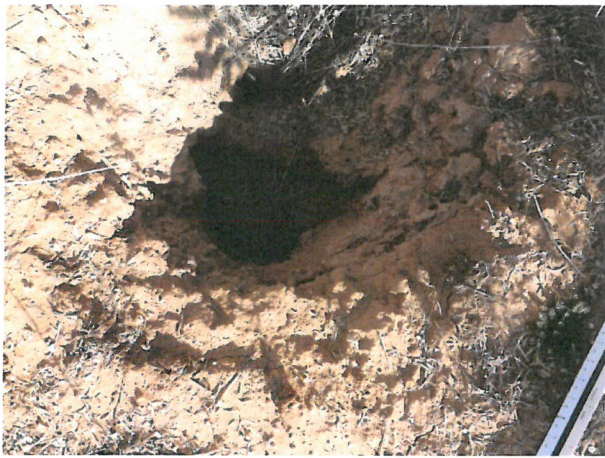
**Photo D.3-26** Hole H-23 (1.5'W x 1.55'L x 0.65'D)

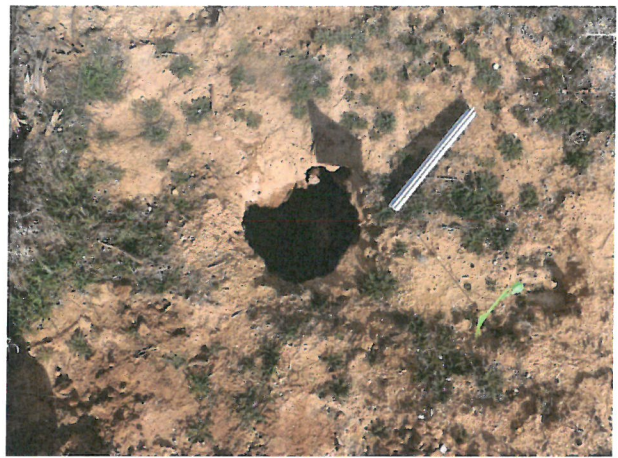
**Photo D.3-27** Hole H-24 (1.7'W x 2.0'L x 1.25'D)

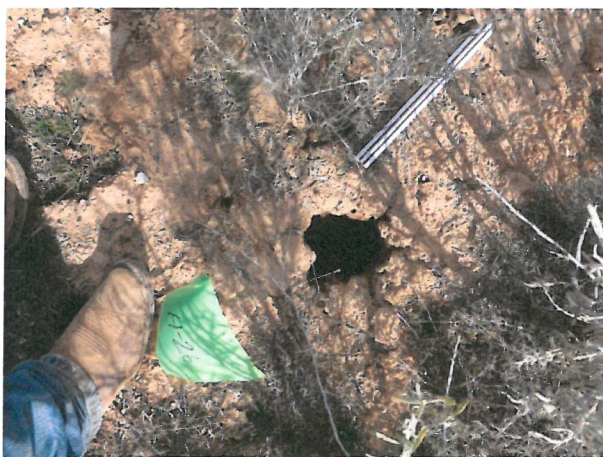
**Photo D.3-28** Hole H-25 (0.9'W x 1.0'L x 0.9'D)

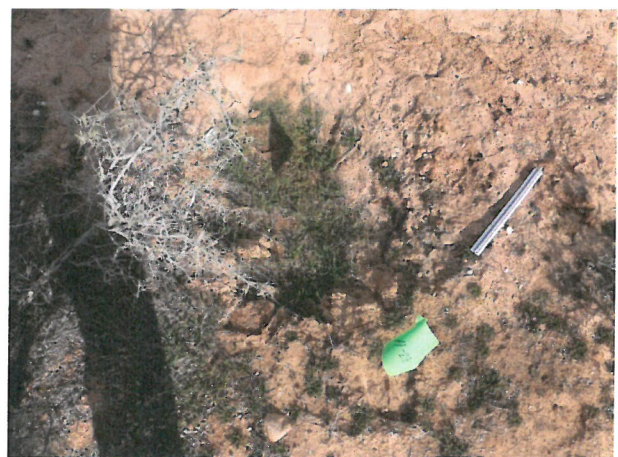
**Photo D.3-29** Hole H-26(0.45'W x 0.4'L x 1.35'D)

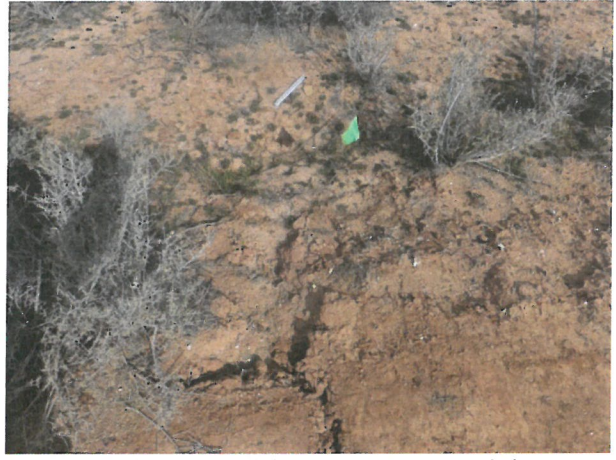
**Photo D.3-31** Hole H-28 (4.6'W x 4.0'L x 0.65'D)

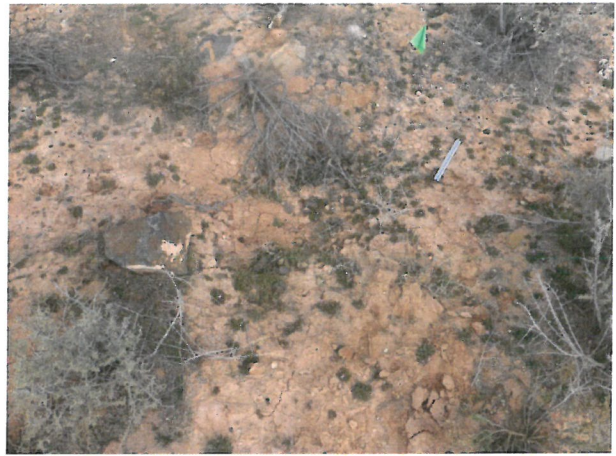
**Photo D.3-33** Hole H-30 (4.5'W x 4.5'L x 2.6'D)

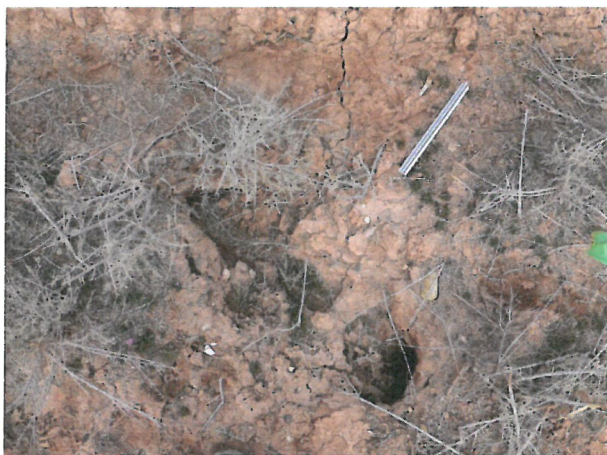
**Photo D.3-34** Hole H-31 (3.8'W x 4.2'L x 0.85'D)

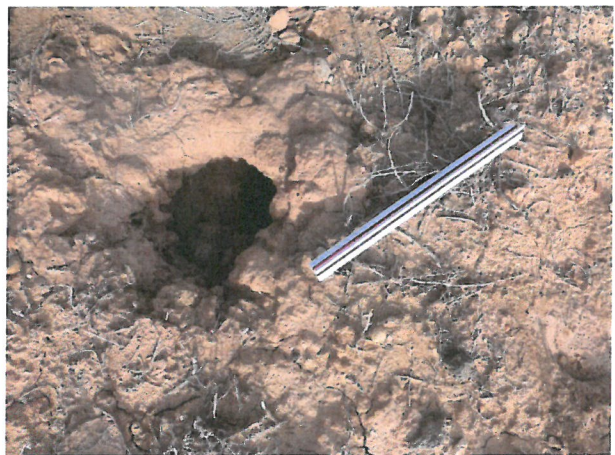
**Photo D.3-35** Hole H-32 (3.1'W x 2.5'L x 1.0'D)

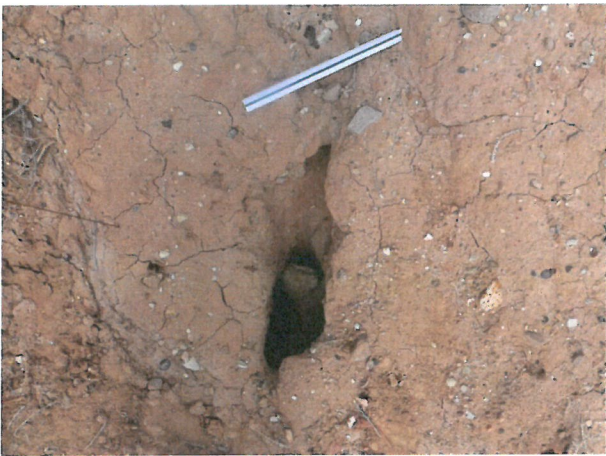
**Photo D.3-38** Hole H-36 (1.5'W x 1.9'L x 1.3'D)

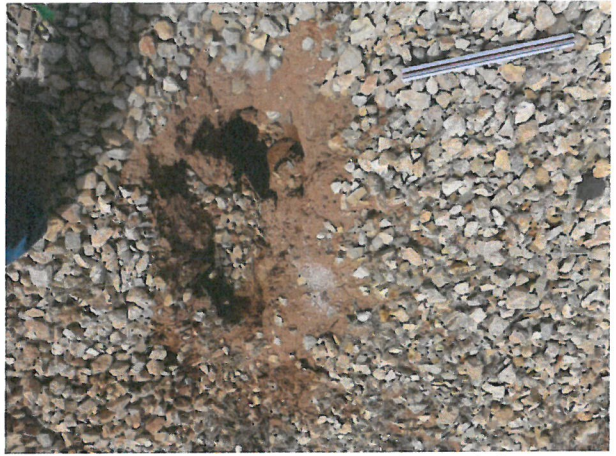
**Photo D.3-39** Hole H-37 (0.85'W x 1.6'L x 4.6'D)

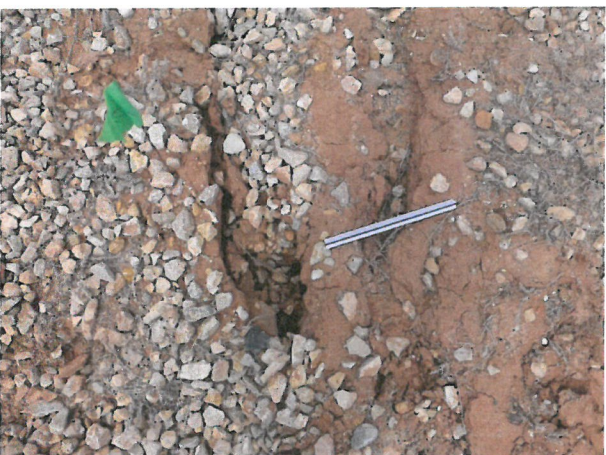
**Photo D.3-40** Hole H-38 (1.3'W x 2.2'L x 2.4'D)

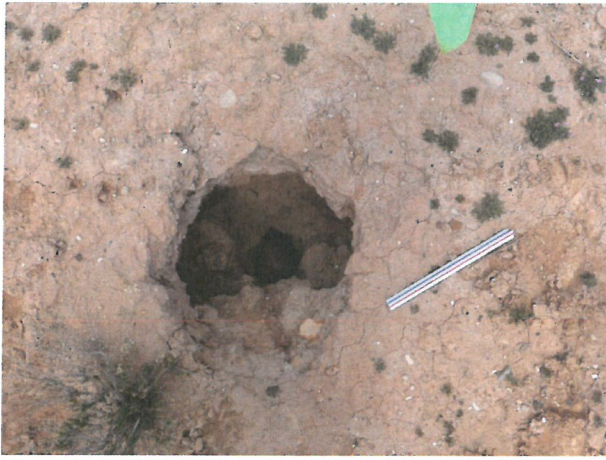
**Photo D.3-42** Hole H-40 (1.4'W x 5.0'L x 1.1'D)

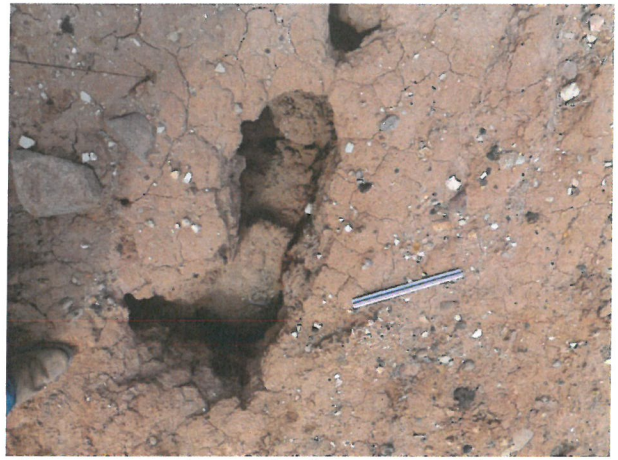
**Photo D.3-43** Hole H-41 (1.6'W x 1.95'L x 2.65'D)

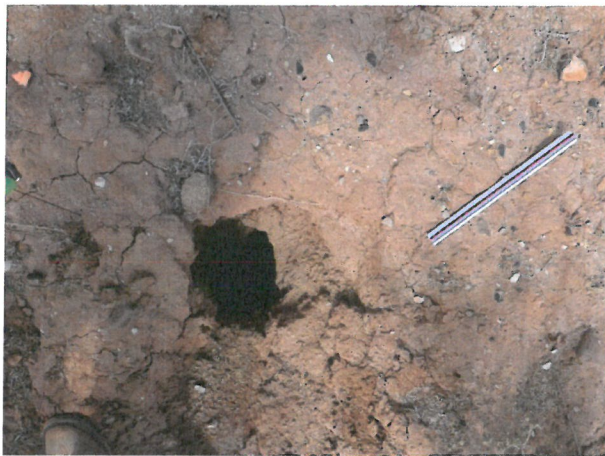
**Photo D.3-44** Hole H-42 (1.9'W x 3.7'L x 2.7'D)

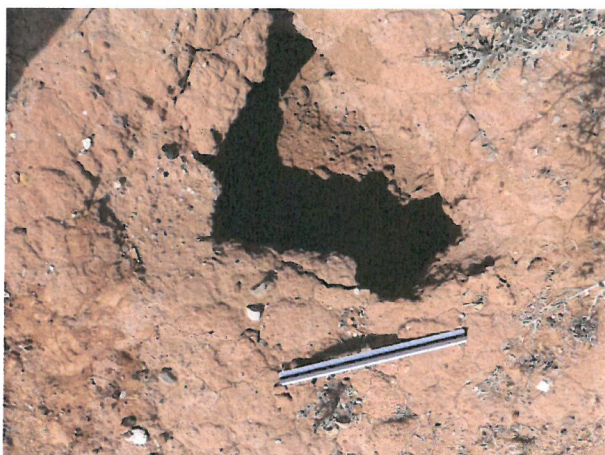
**Photo D.3-46** Hole H-44 (1.25'W x 1.1'L x 2.0'D)

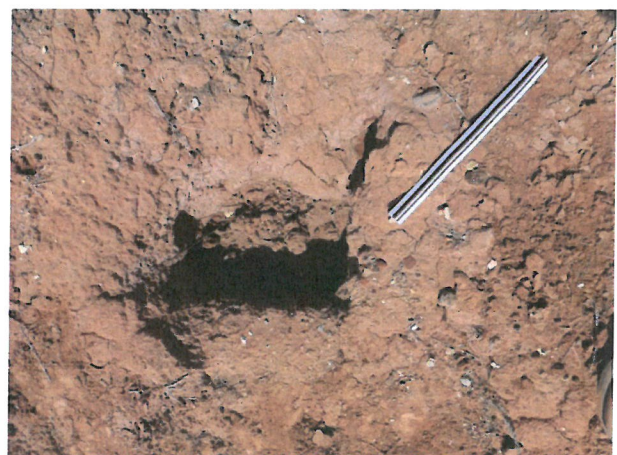
**Photo D.3-47** Hole H-45 (1.8'W x 1.4'L x 1.6'D)

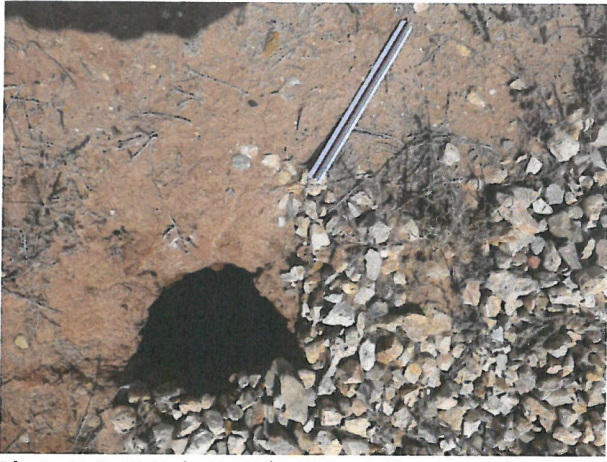
**Photo D.3-48** Hole H-46 (1.55'W x 1.25'L x 1.15'D)

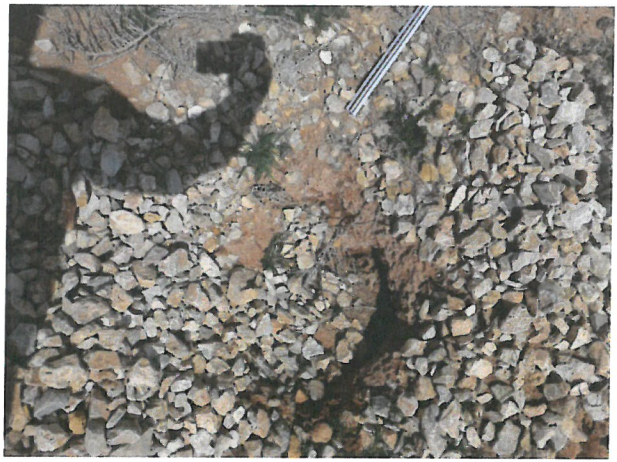
**Photo D.3-49** Hole H-47 (1.1'W x 0.8'L x 2.55'D)

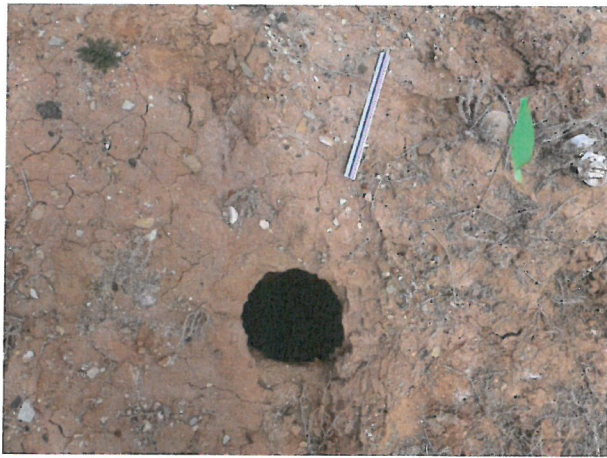
**Photo D.3-50** Hole H-48 (1.45'W x 1.5'L x 1.0'D)

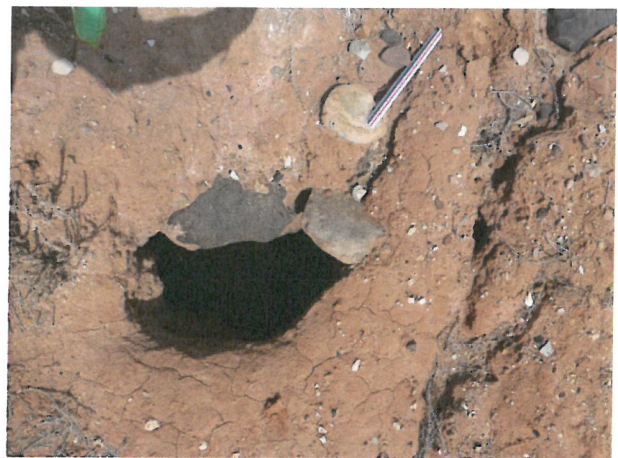
**Photo D.3-51** Hole H-49 (0.75'W x 0.65'L x 3.2'D)

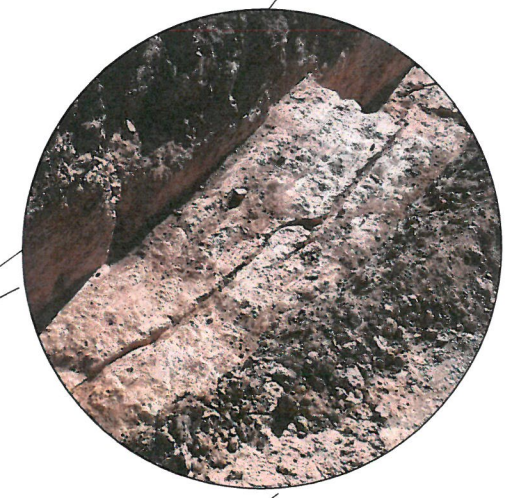
SEE PHOTO A.3-11

**Photo D.2-A3-11** – T-13 location: Looking northwest into trench at the crack located in the upper northwest wall.
